Safety of Nuclear Reactors

Professor H. MOCHIZUKI

Nuclear Reactor Thermal Hydraulics Division

University of Fukui

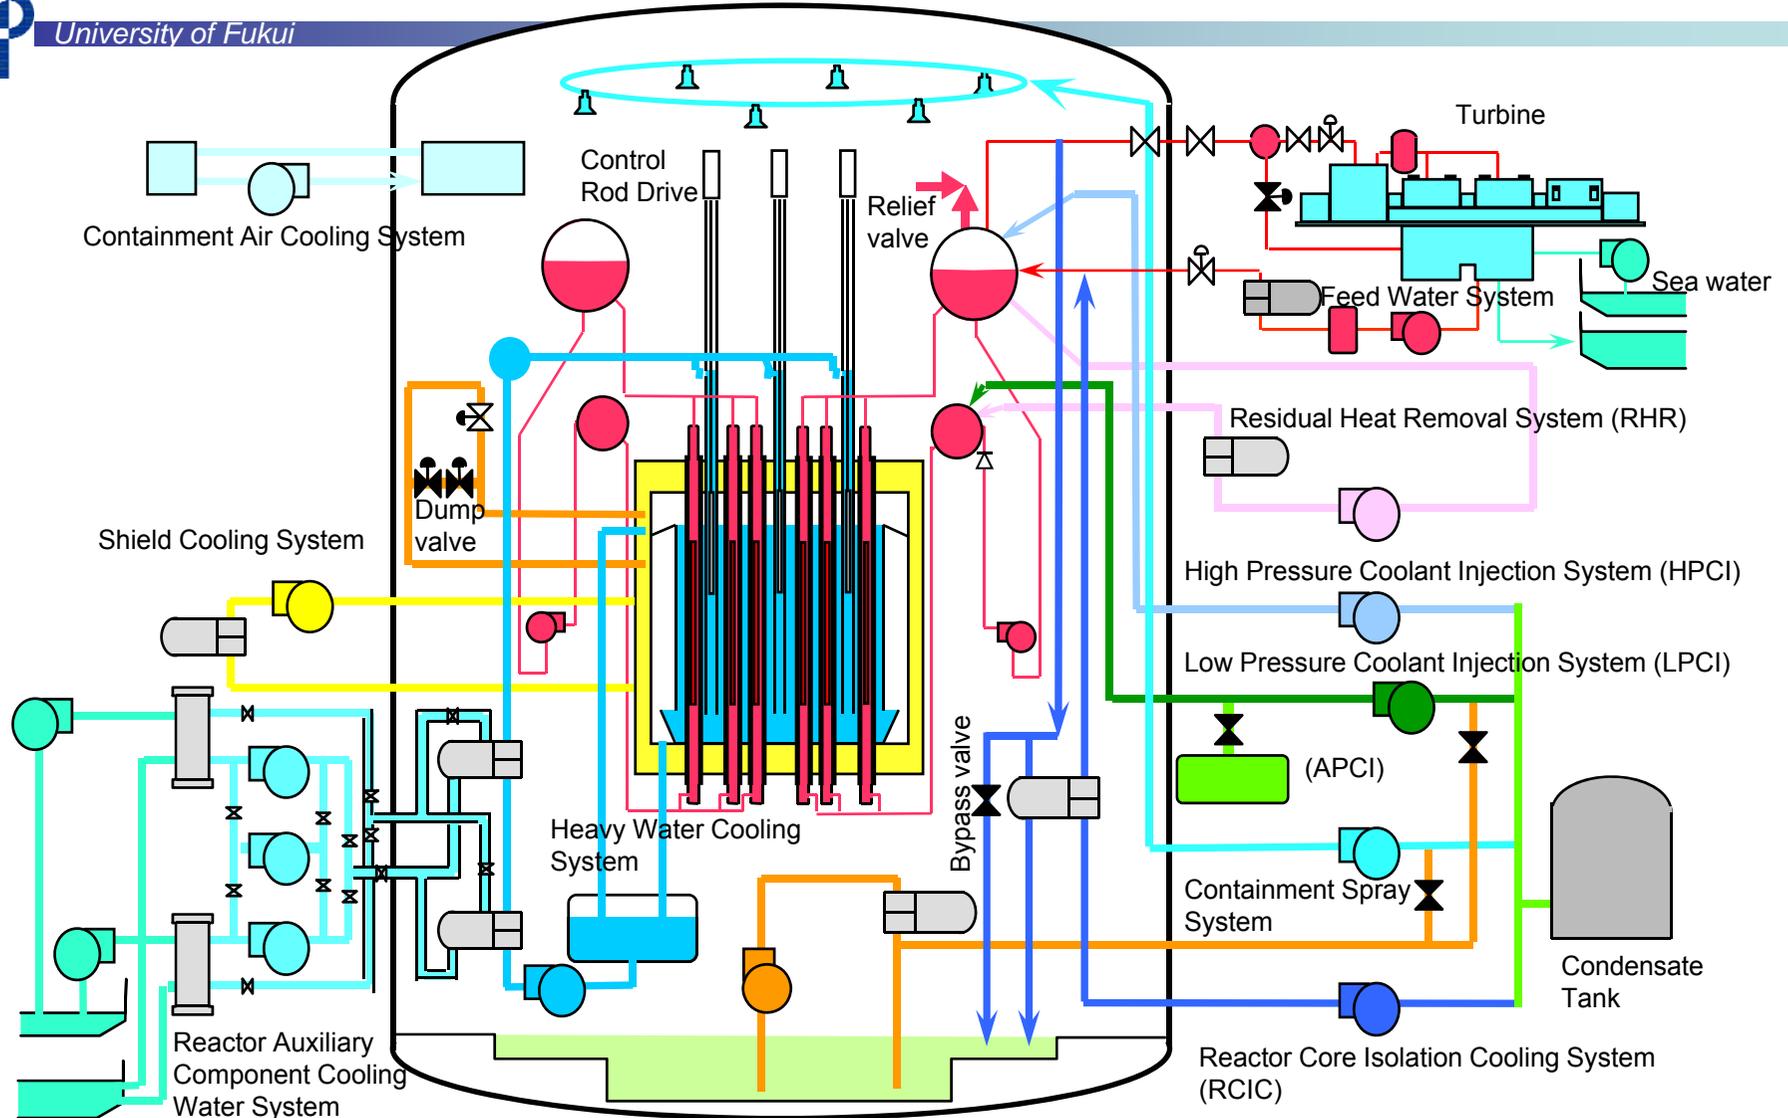
ECCS

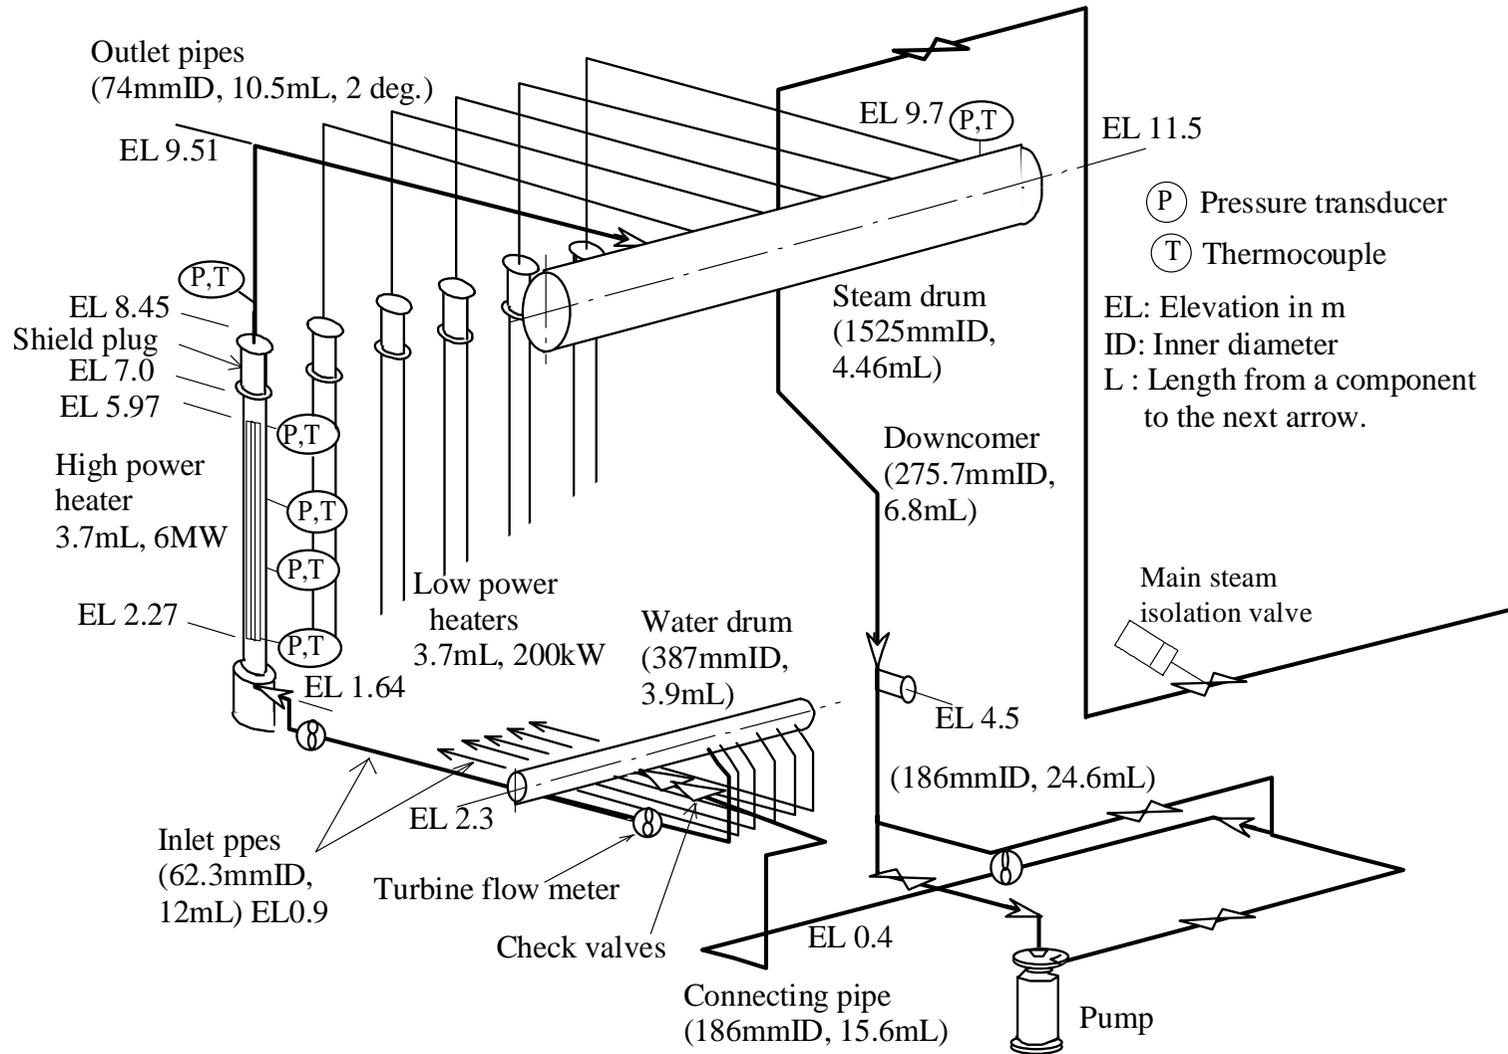
6MW ATR Safety Experimental Facility

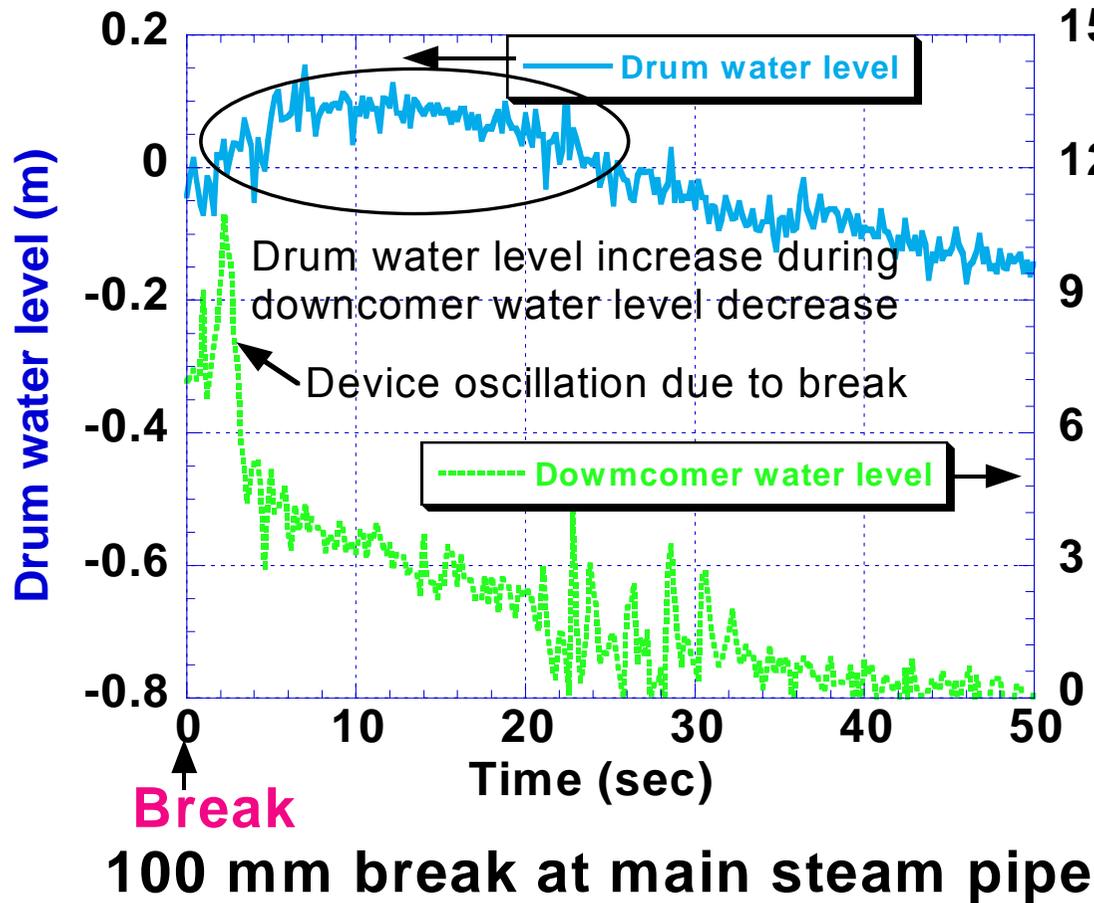
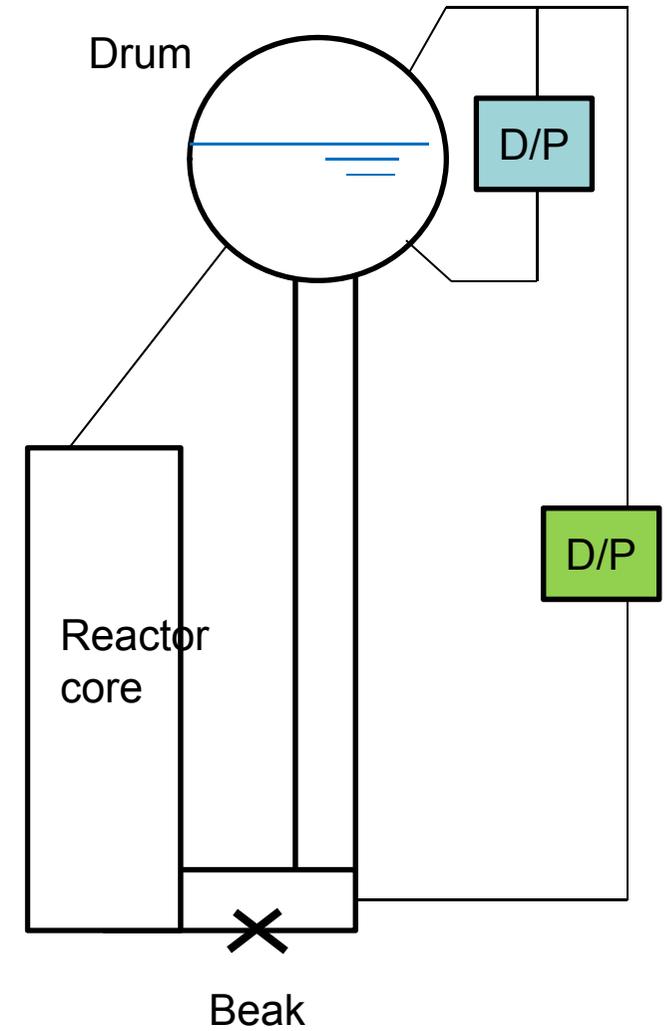
Water level behavior after a main steam pipe break

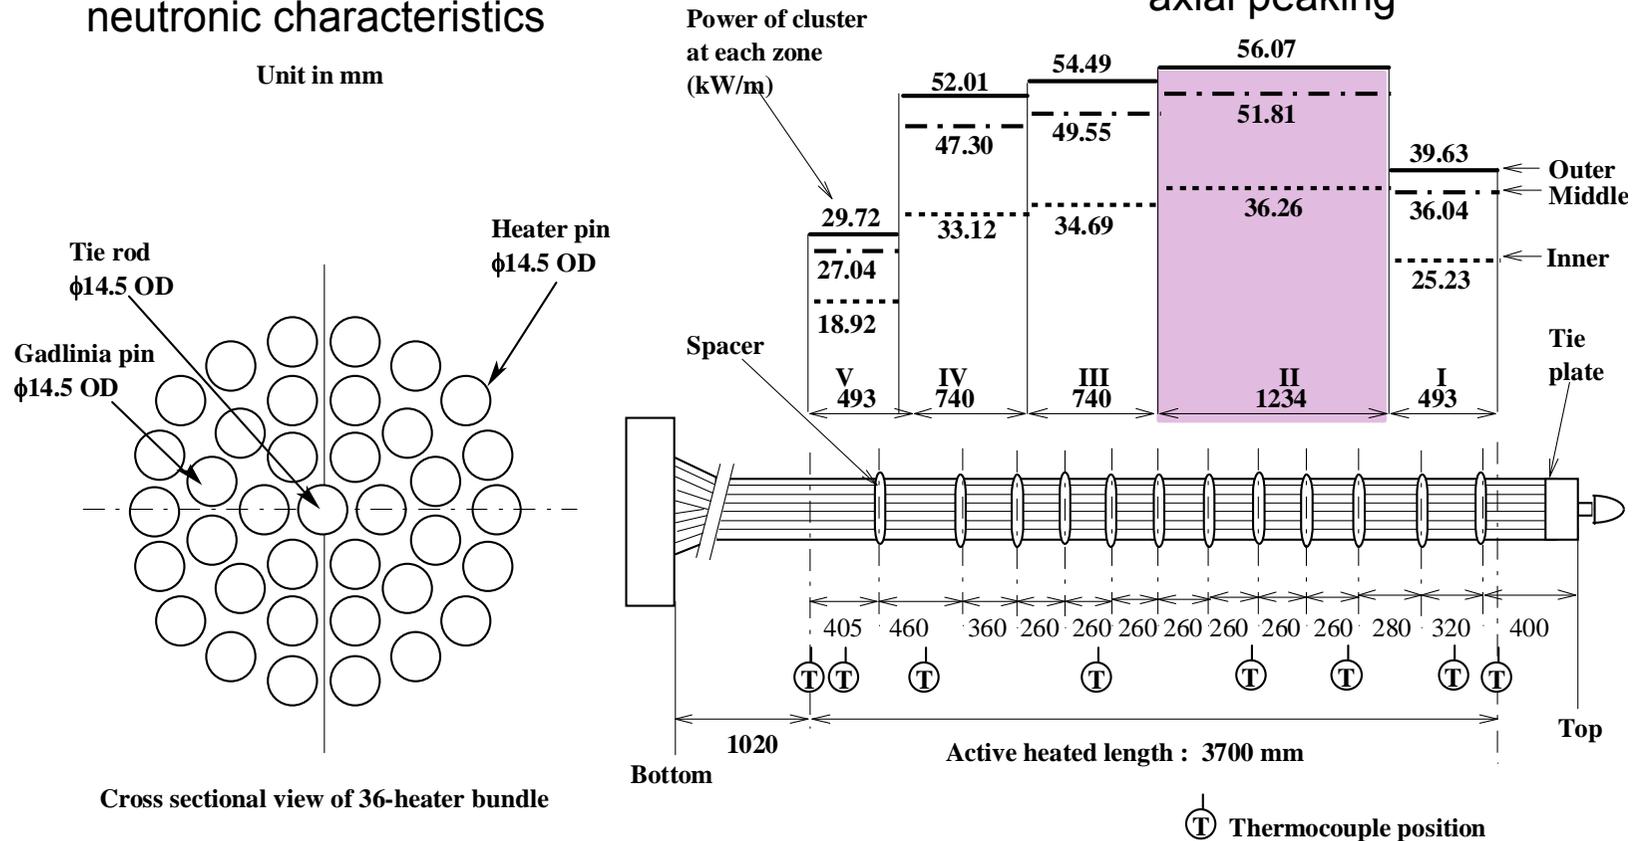
Fig. 7 Power distribution of 36-rod high power heater

Local peaking is high for the outer rods due to the neutronic characteristics

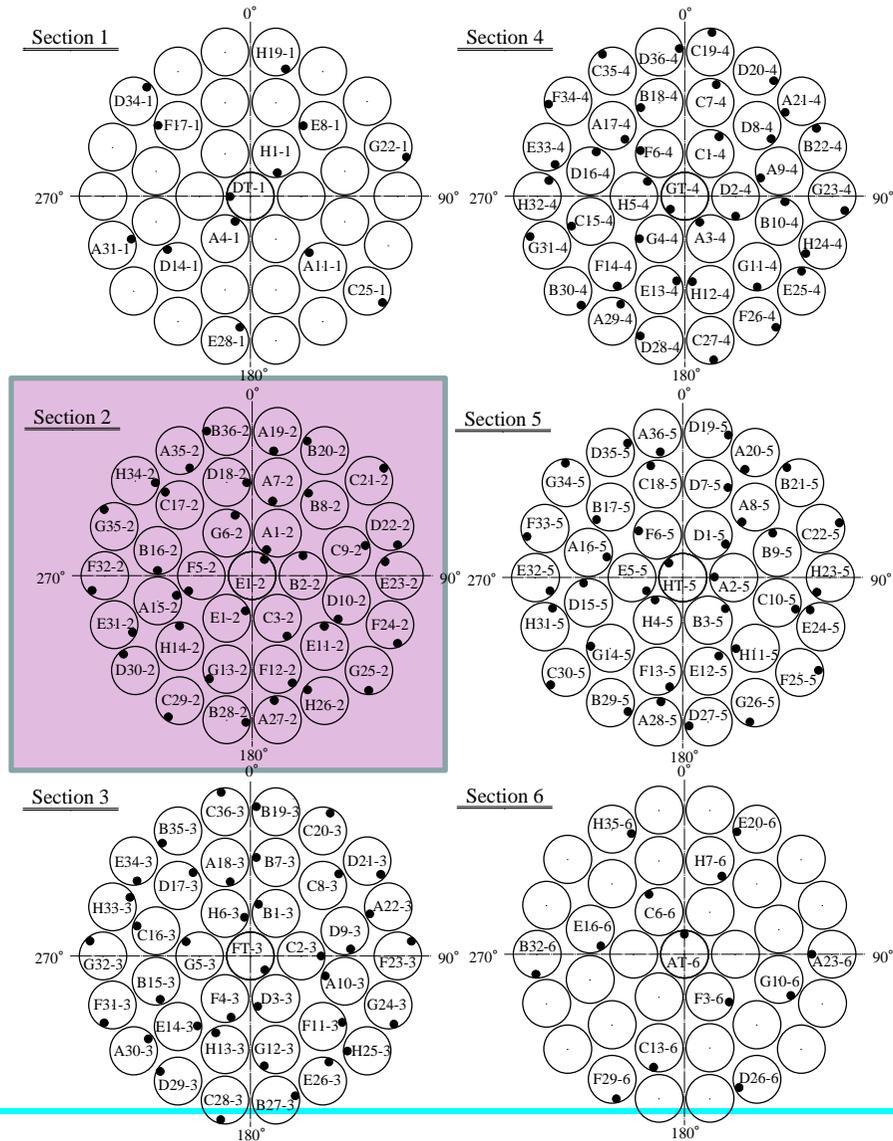
Fig. 8 Thermocouple positions on high power heater rods

Thermocouple positions

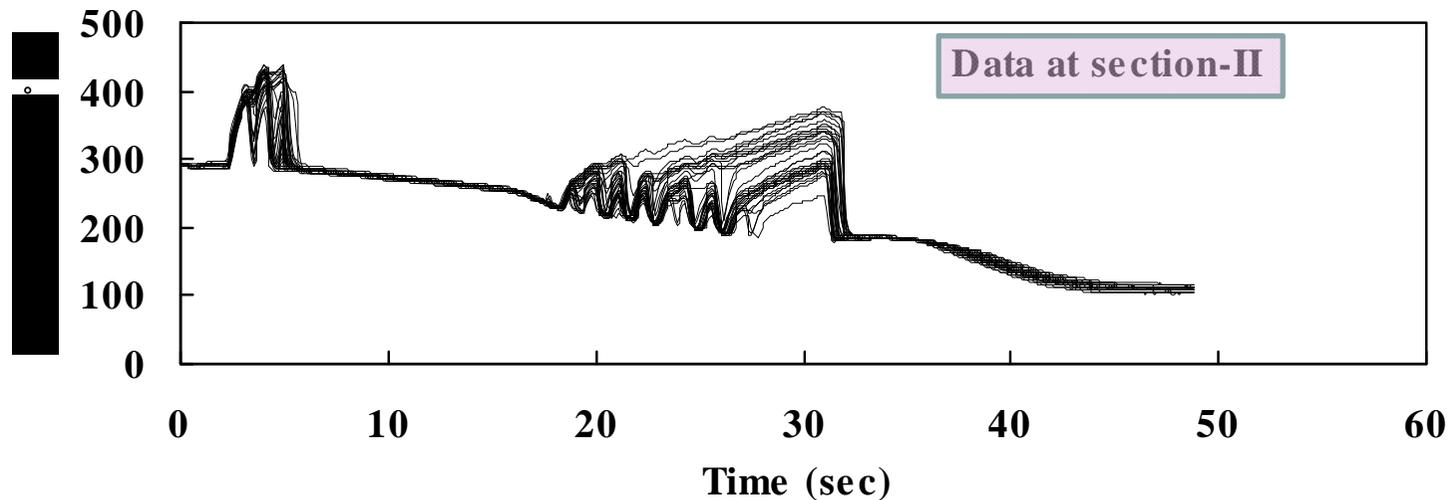
Fig. 14 Experimental cladding temperature for 150 mm downcomer break

Cladding temperature measured in a same cross section of heater bundle

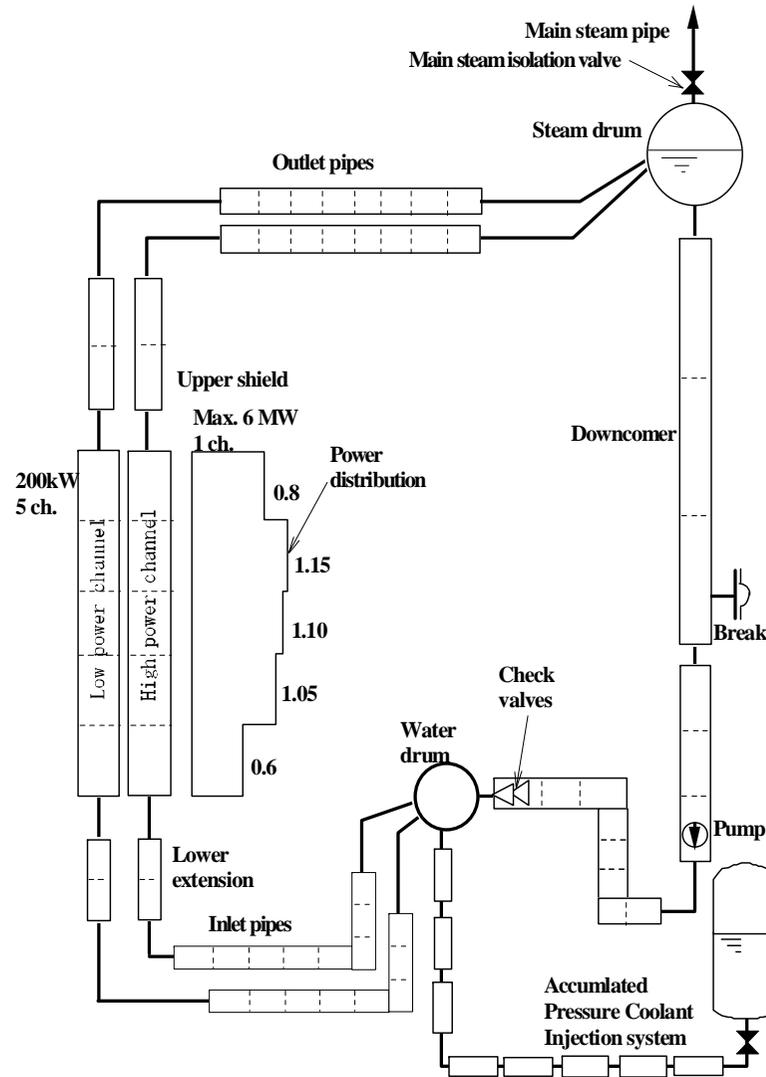
Fig. 9 Nodalization scheme for ATR Safety Experiment Loop

Calculation model of pipe break experiment

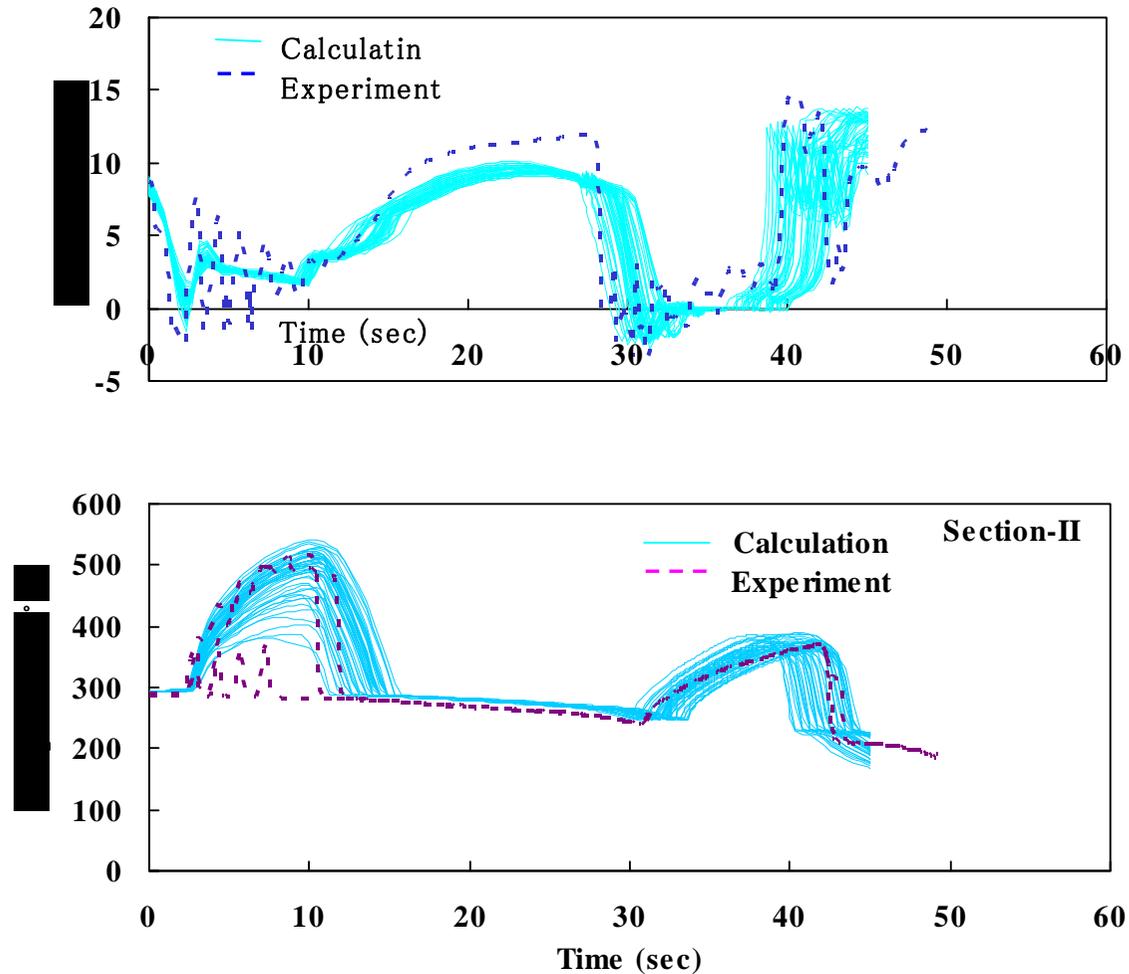
Fig.16 Behavior of cladding temperature after 100 mm downcomer break

Comparison between experimental result and simulation

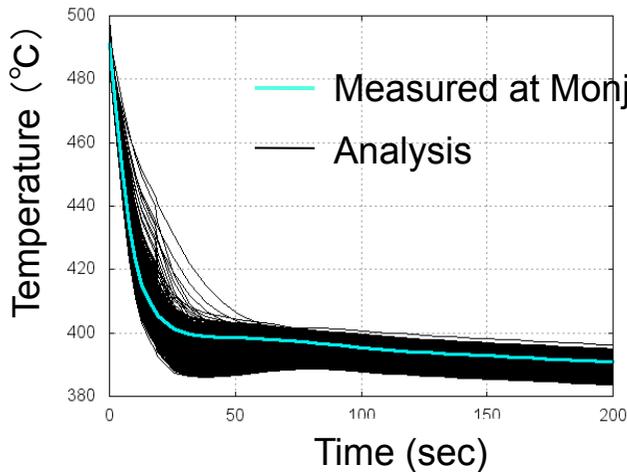
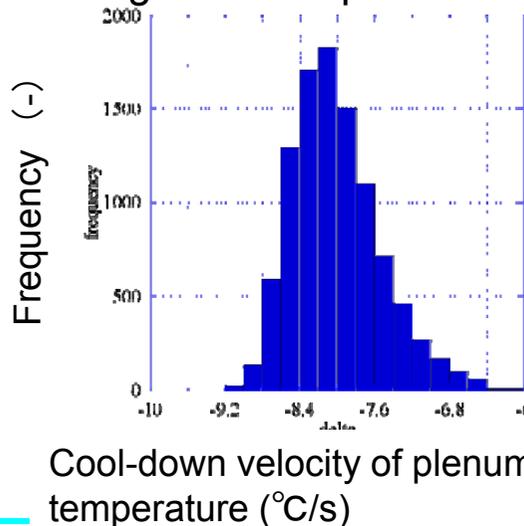
Evolution of plenum temperature during turbine trip

Plant parameters are investigated by 10,000 trials of the Monte-Carlo calculation for 43 factors which can affect on the plenum temperature.

Cool-down velocity of plenum temperature (°C/s)

The measured temperature transient has been included in the group of calculated curves. Most non-safety side value could be evaluated taking into account various statistical errors.

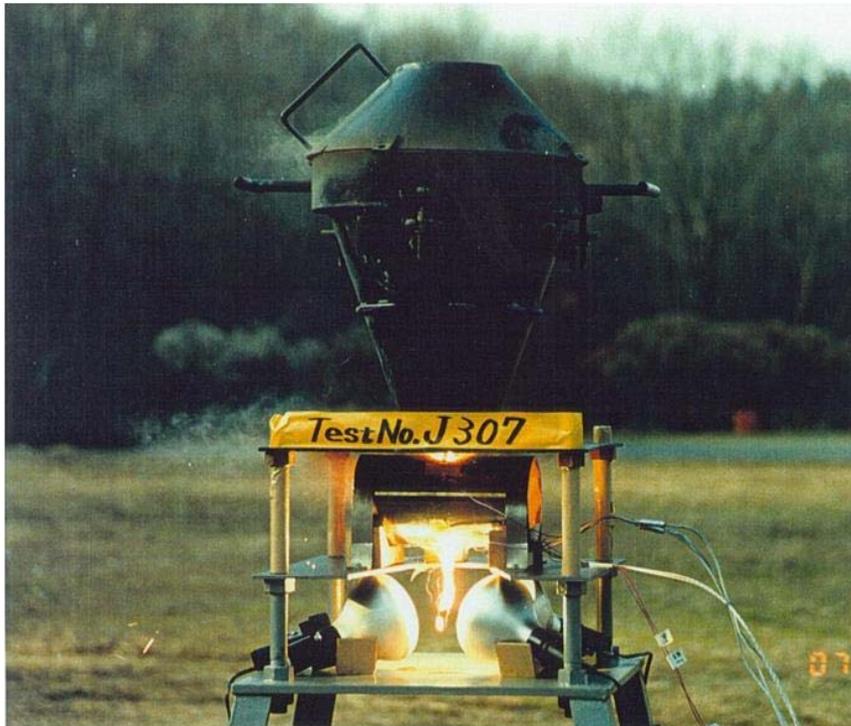
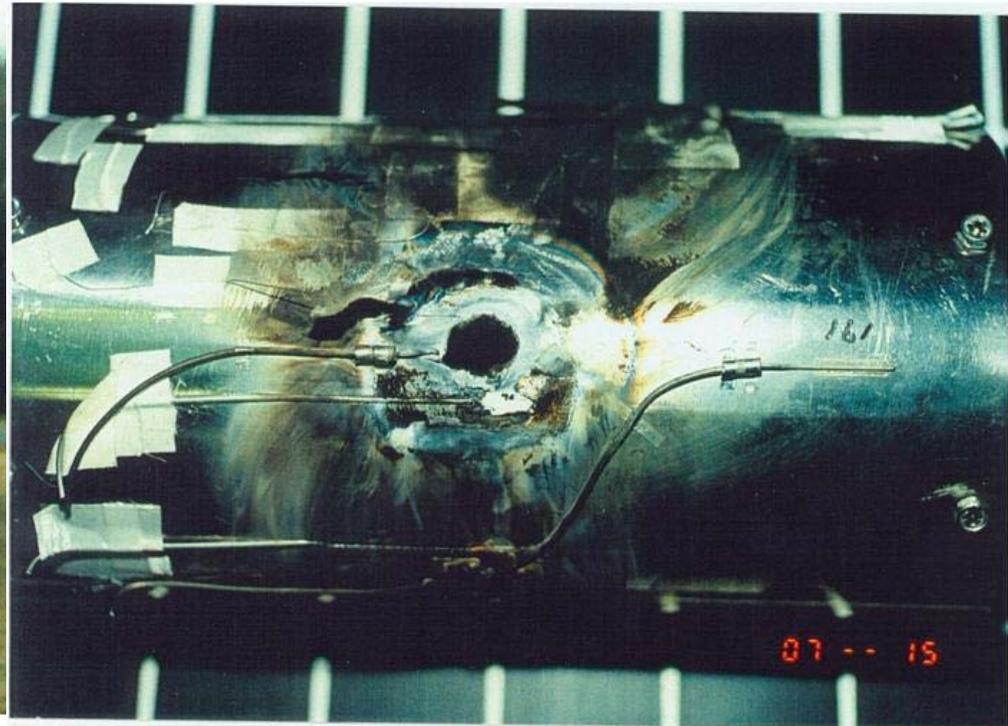
Photo. Erosion experiment of Zr-2.5%Nb pressure tube by molten metal

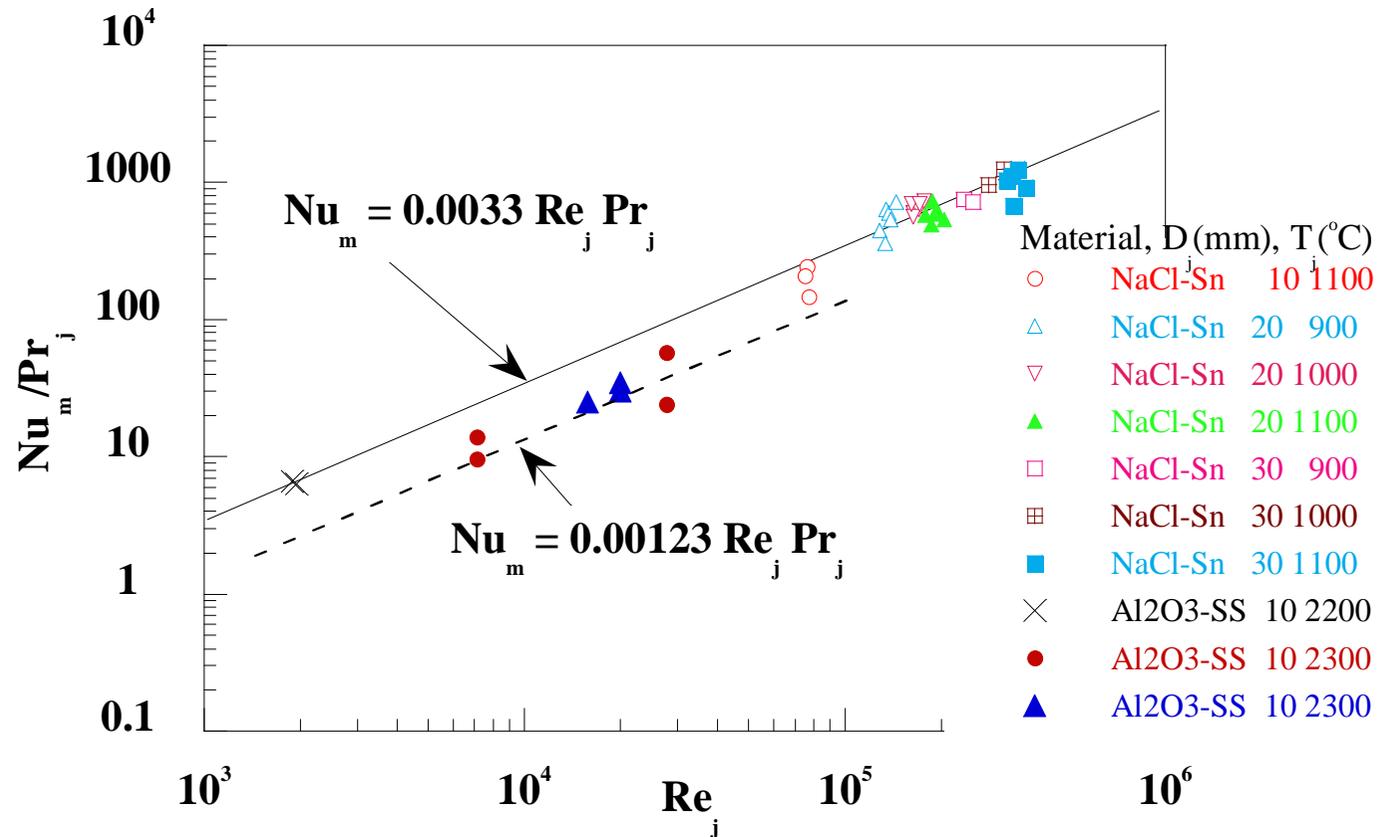
Heat transfer between melted jet and materials

Comparison of Nusselt number between present data and data from Saito et al.1) and Mochizuki2).

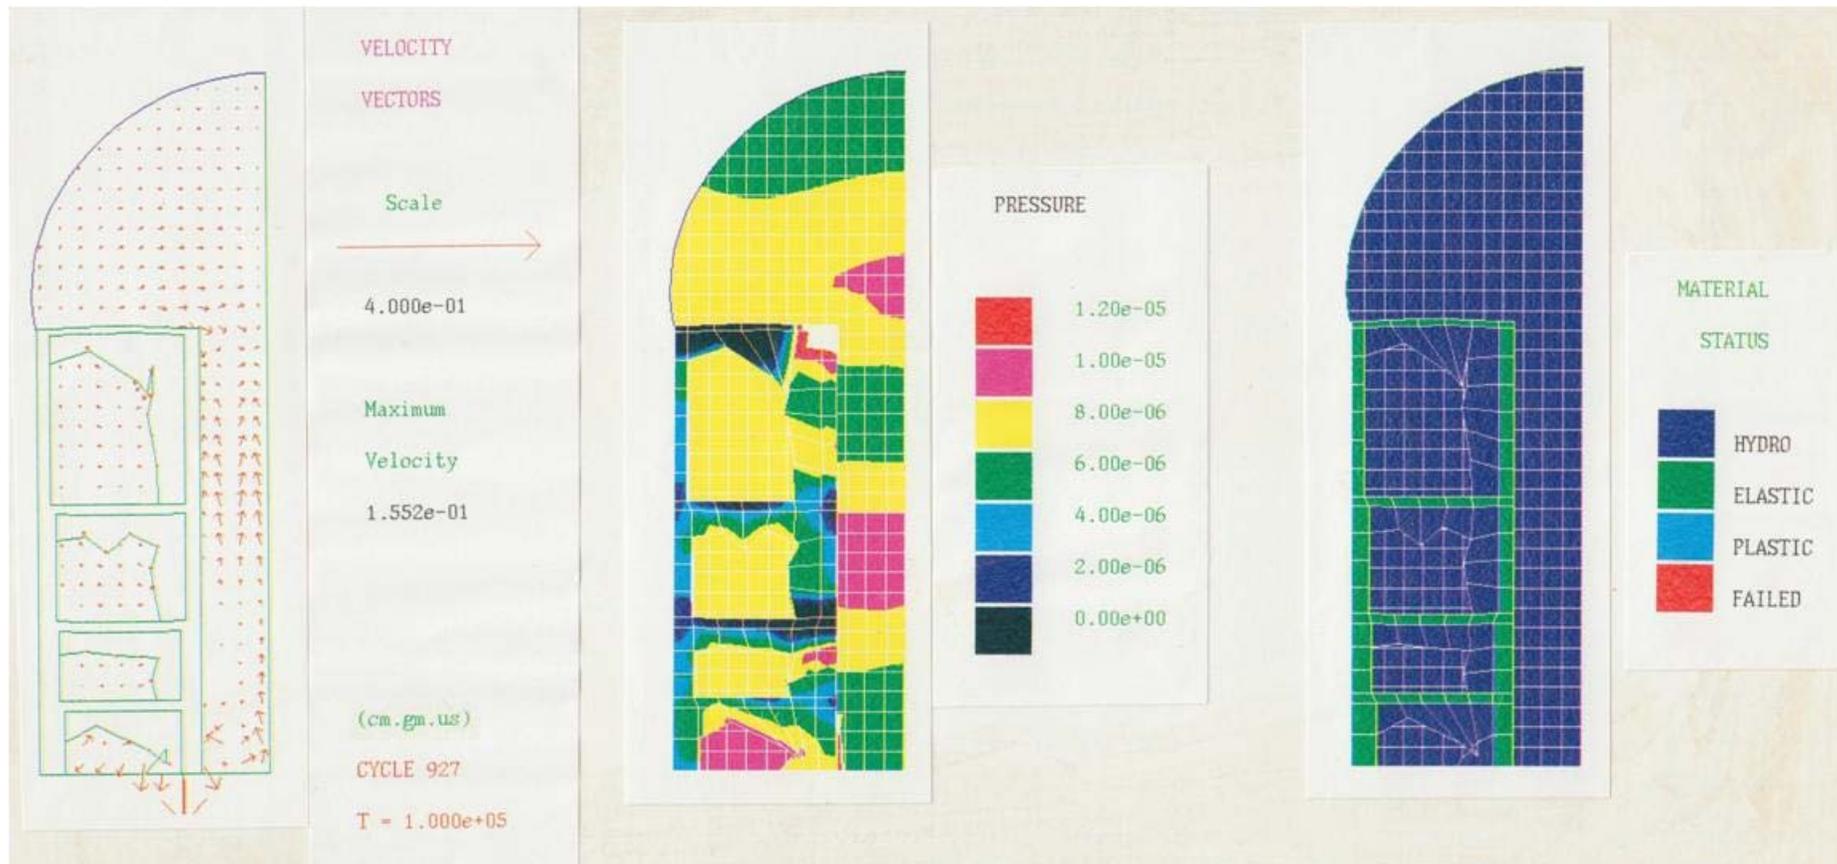
Fluid- structure interaction analysis during hydrogen detonation

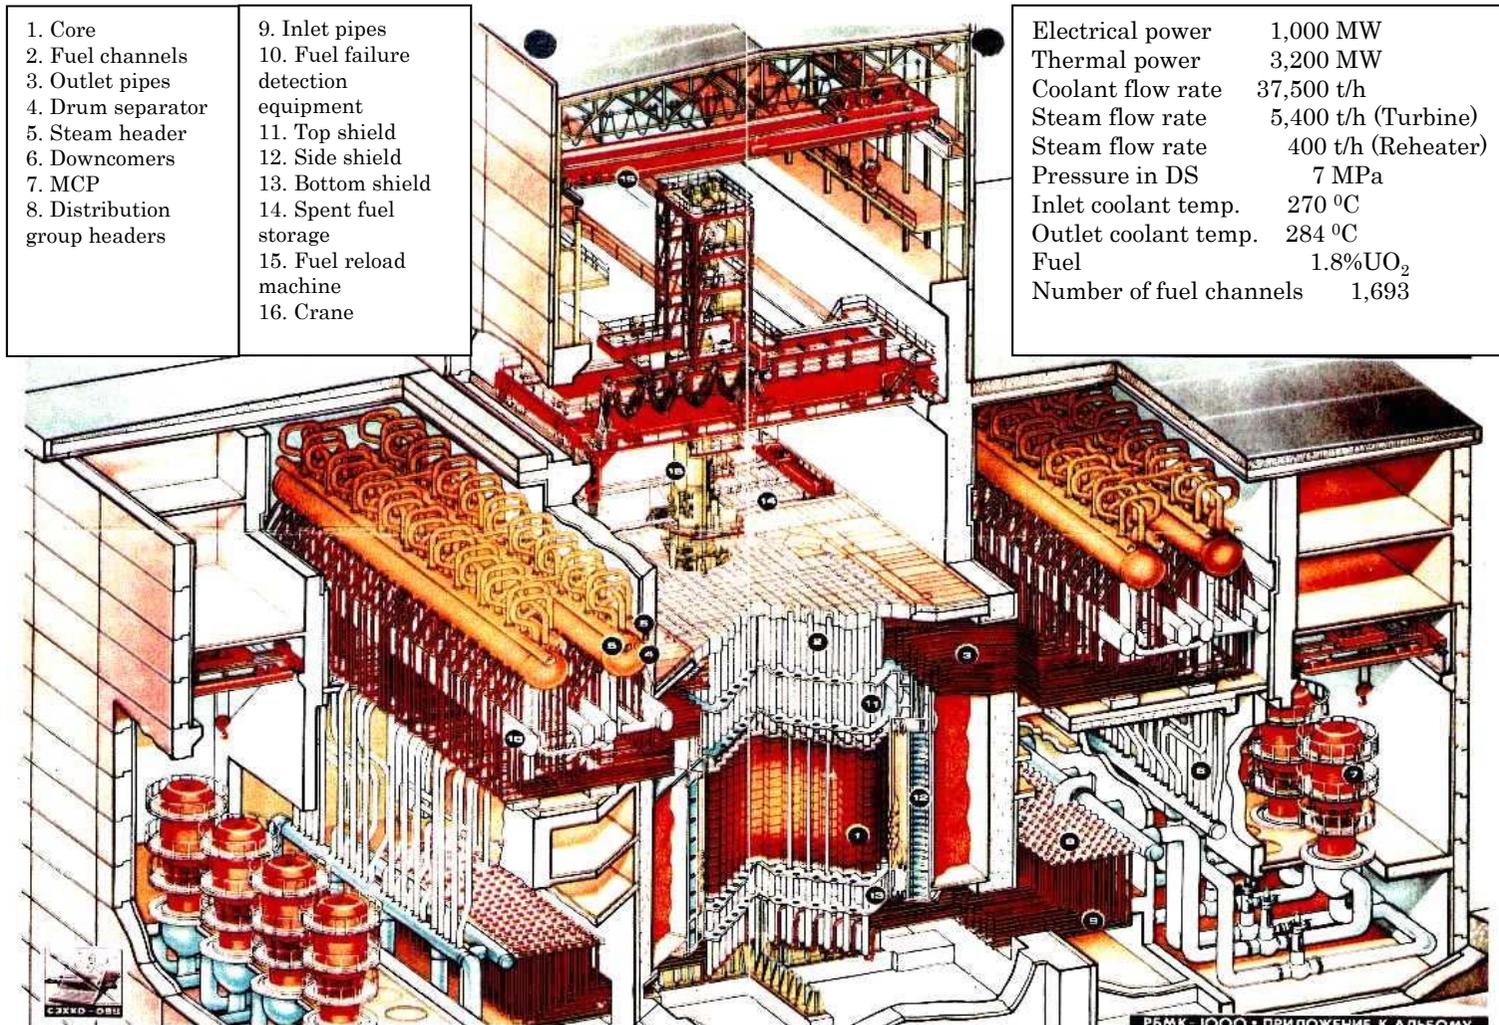
Schematic of Chernobyl NPP

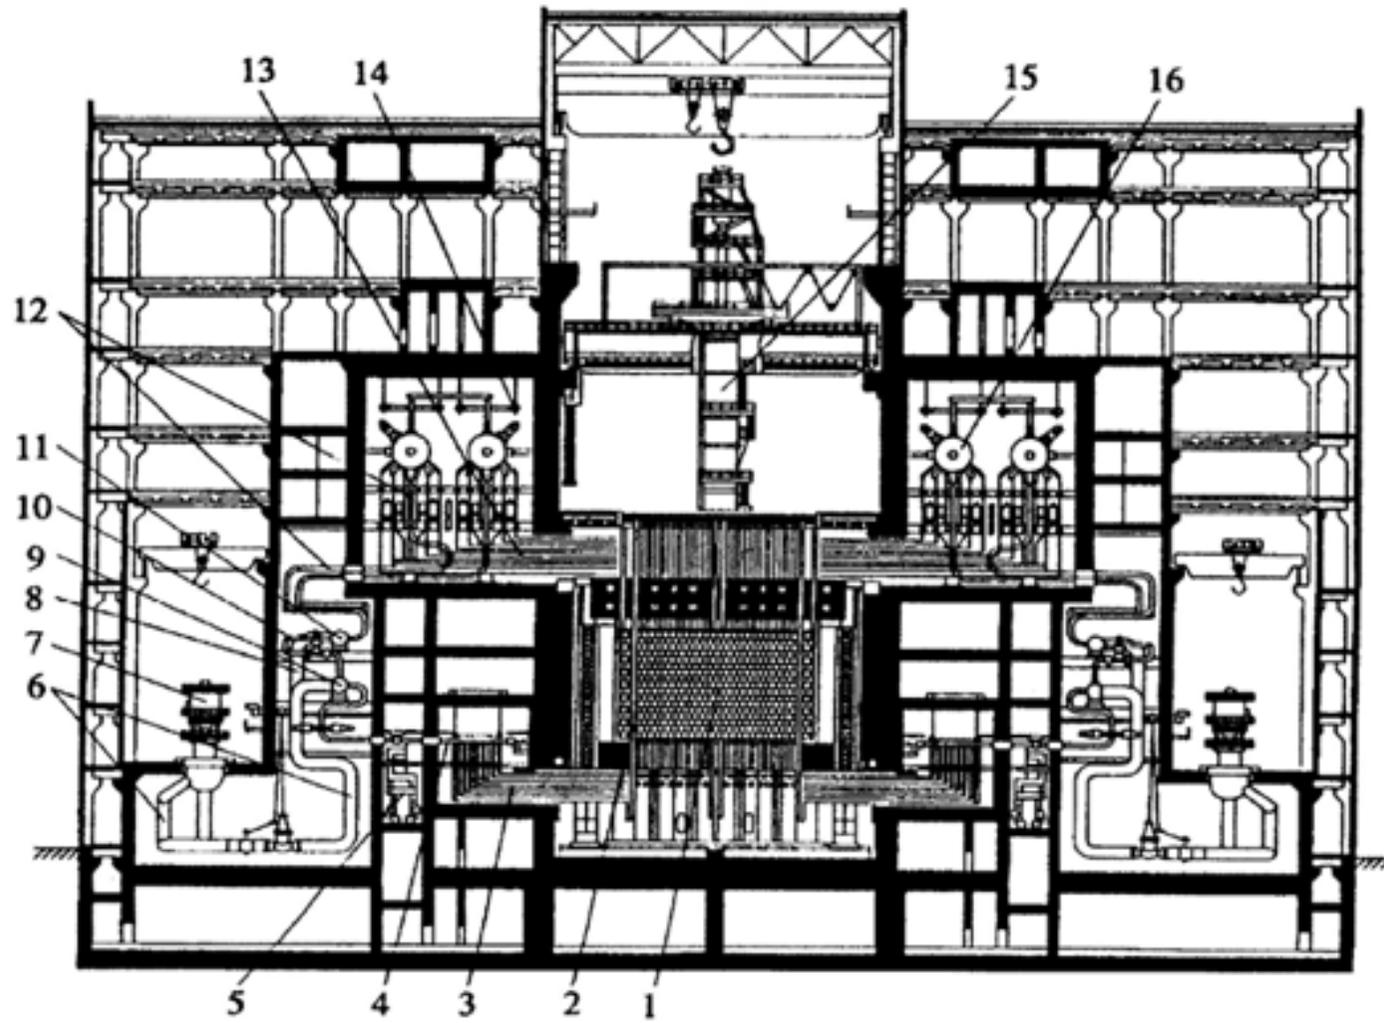
Elevation Plan

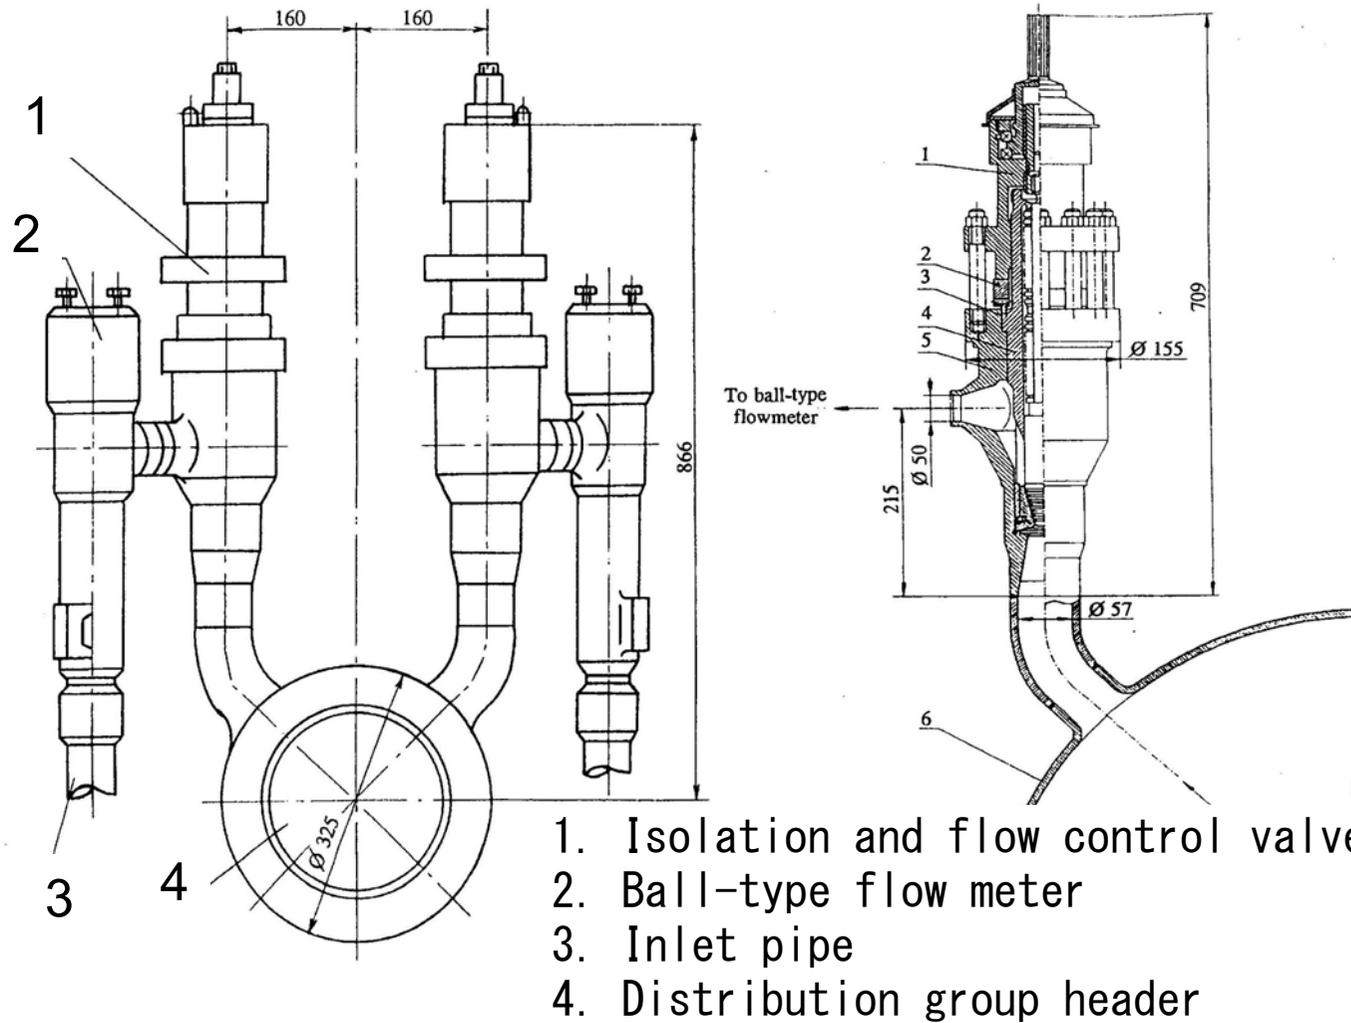
Configuration of inlet valve

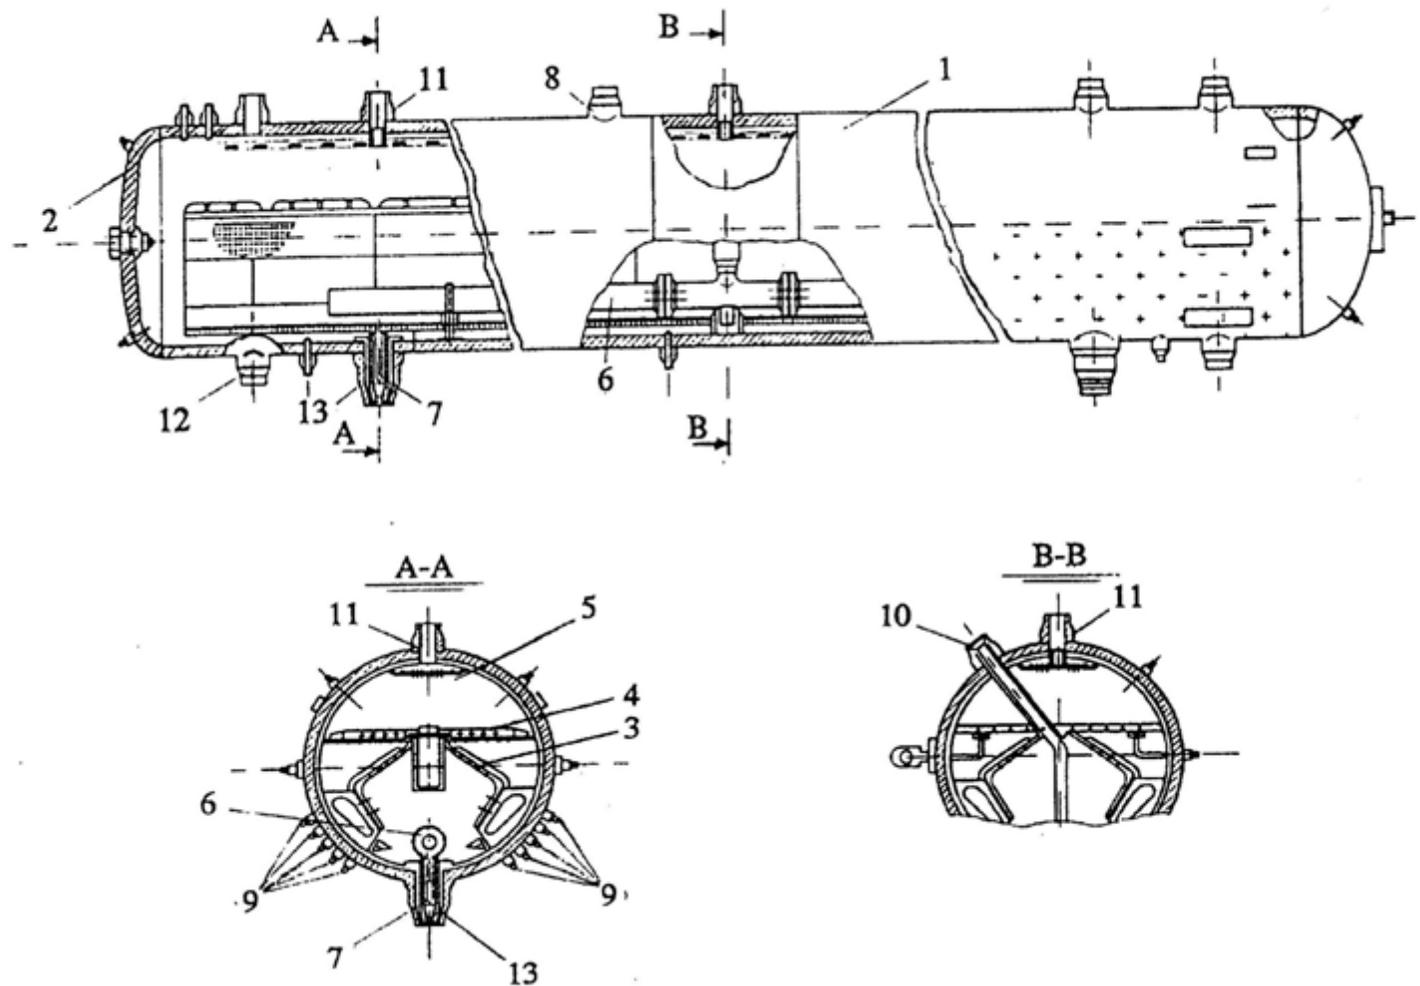
Drum Separator

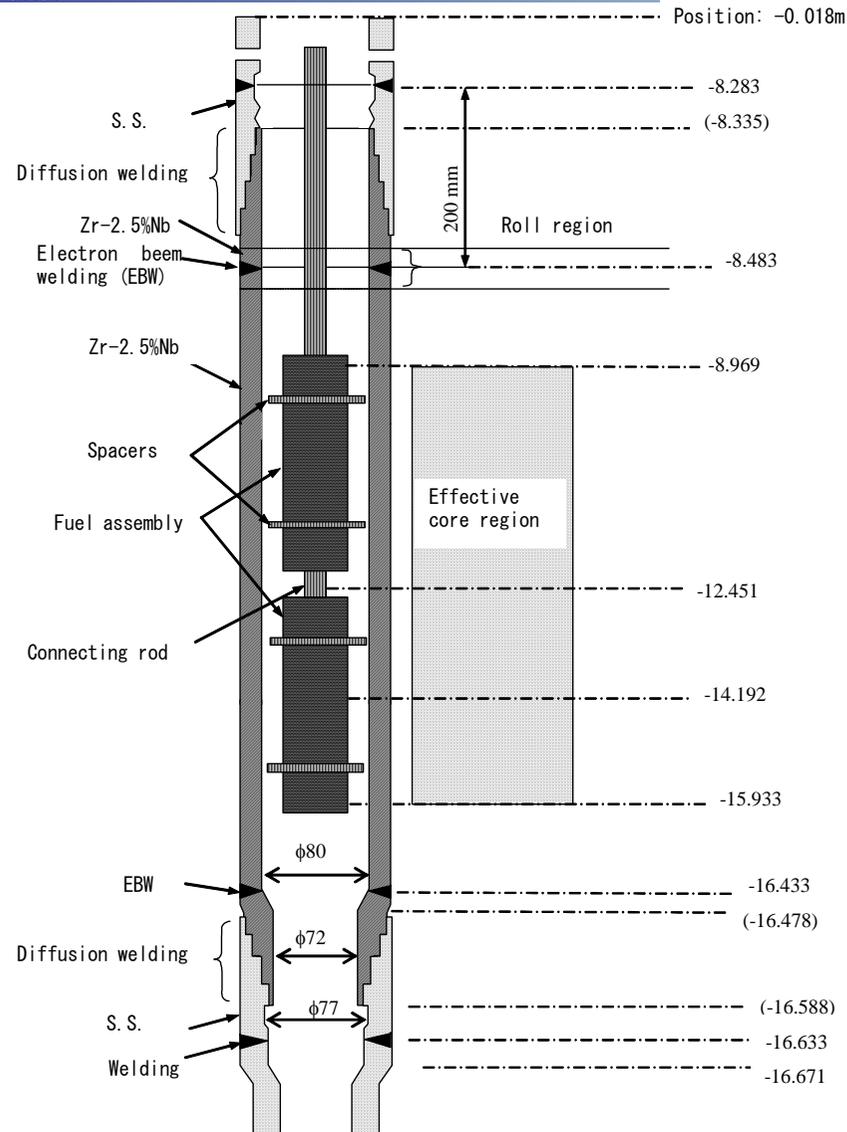
Configuration of Fuel Channel
