Safety of Nuclear Reactors

Professor H. MOCHIZUKI

Nuclear Reactor Thermal Hydraulics Division

University of Fukui

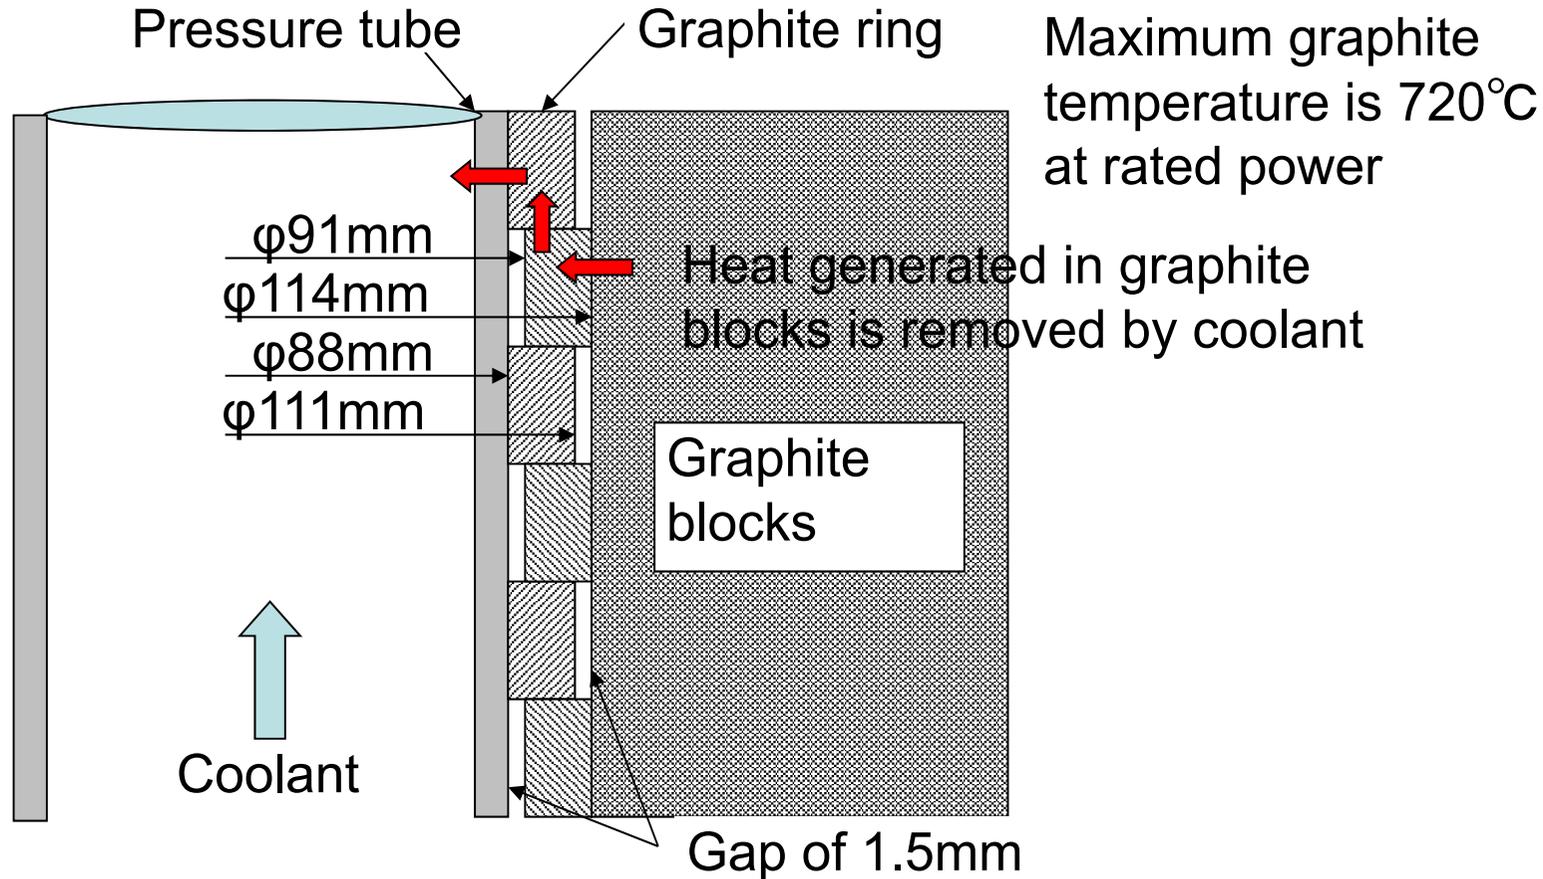
Heat Removal by Moderation

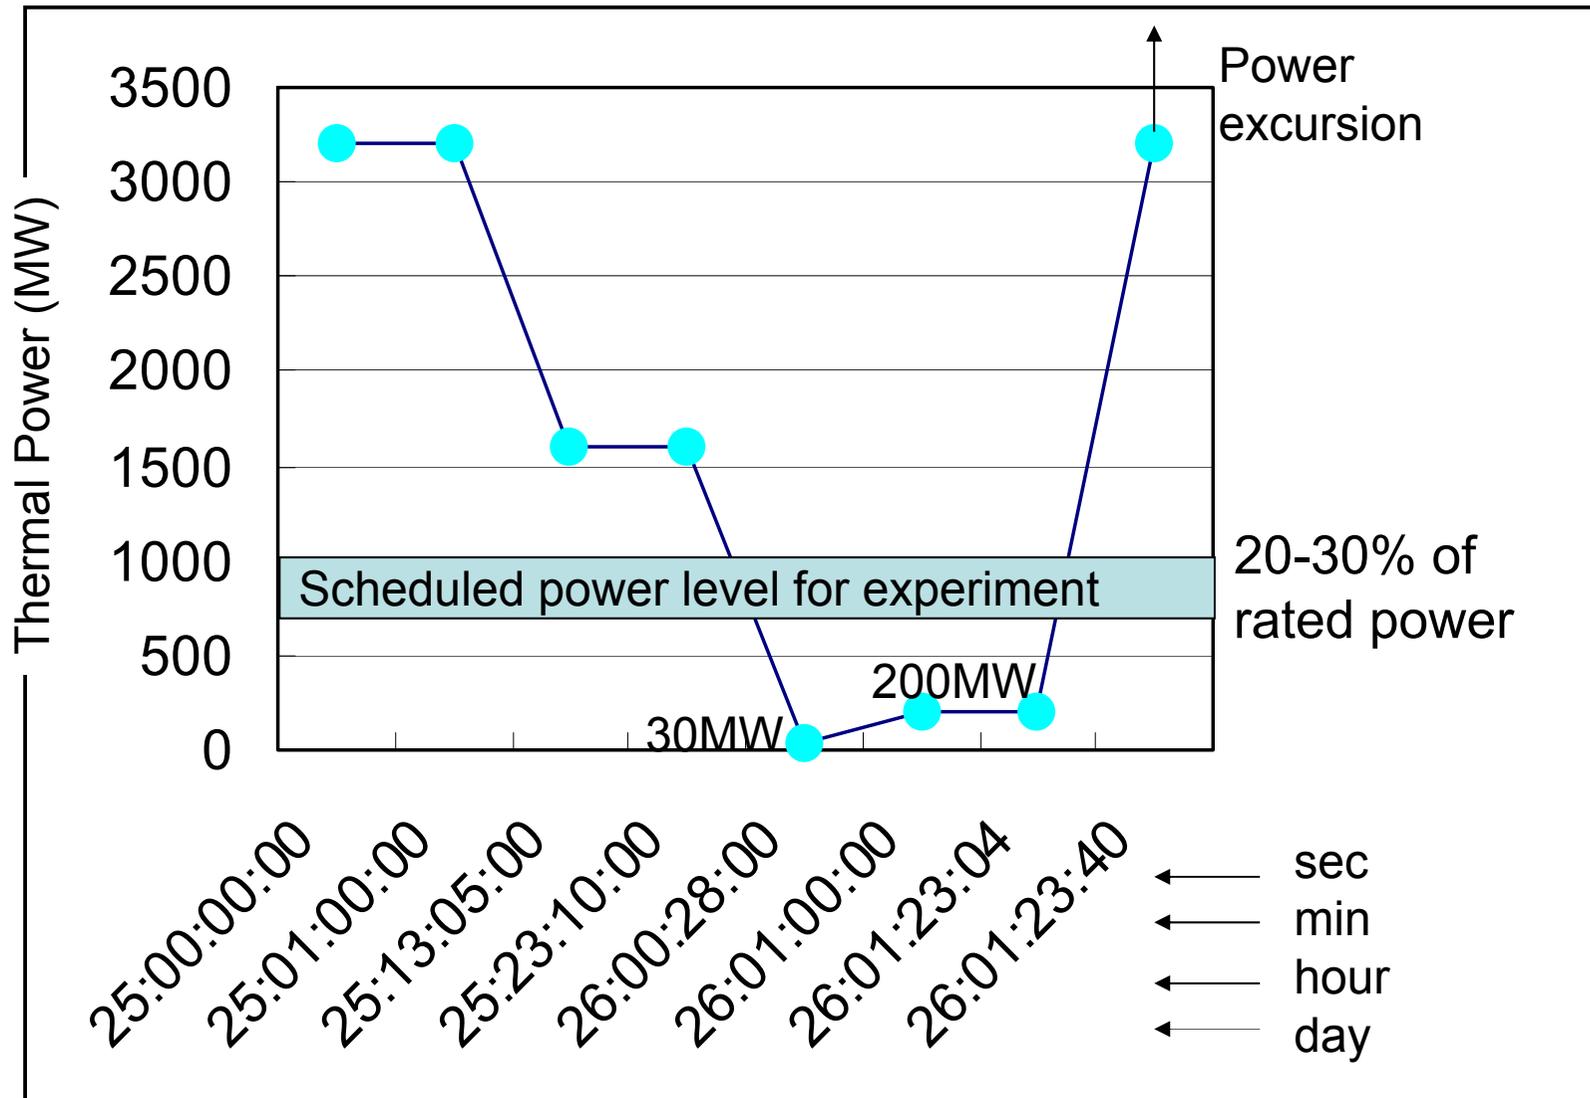
Trend of the Reactor Power

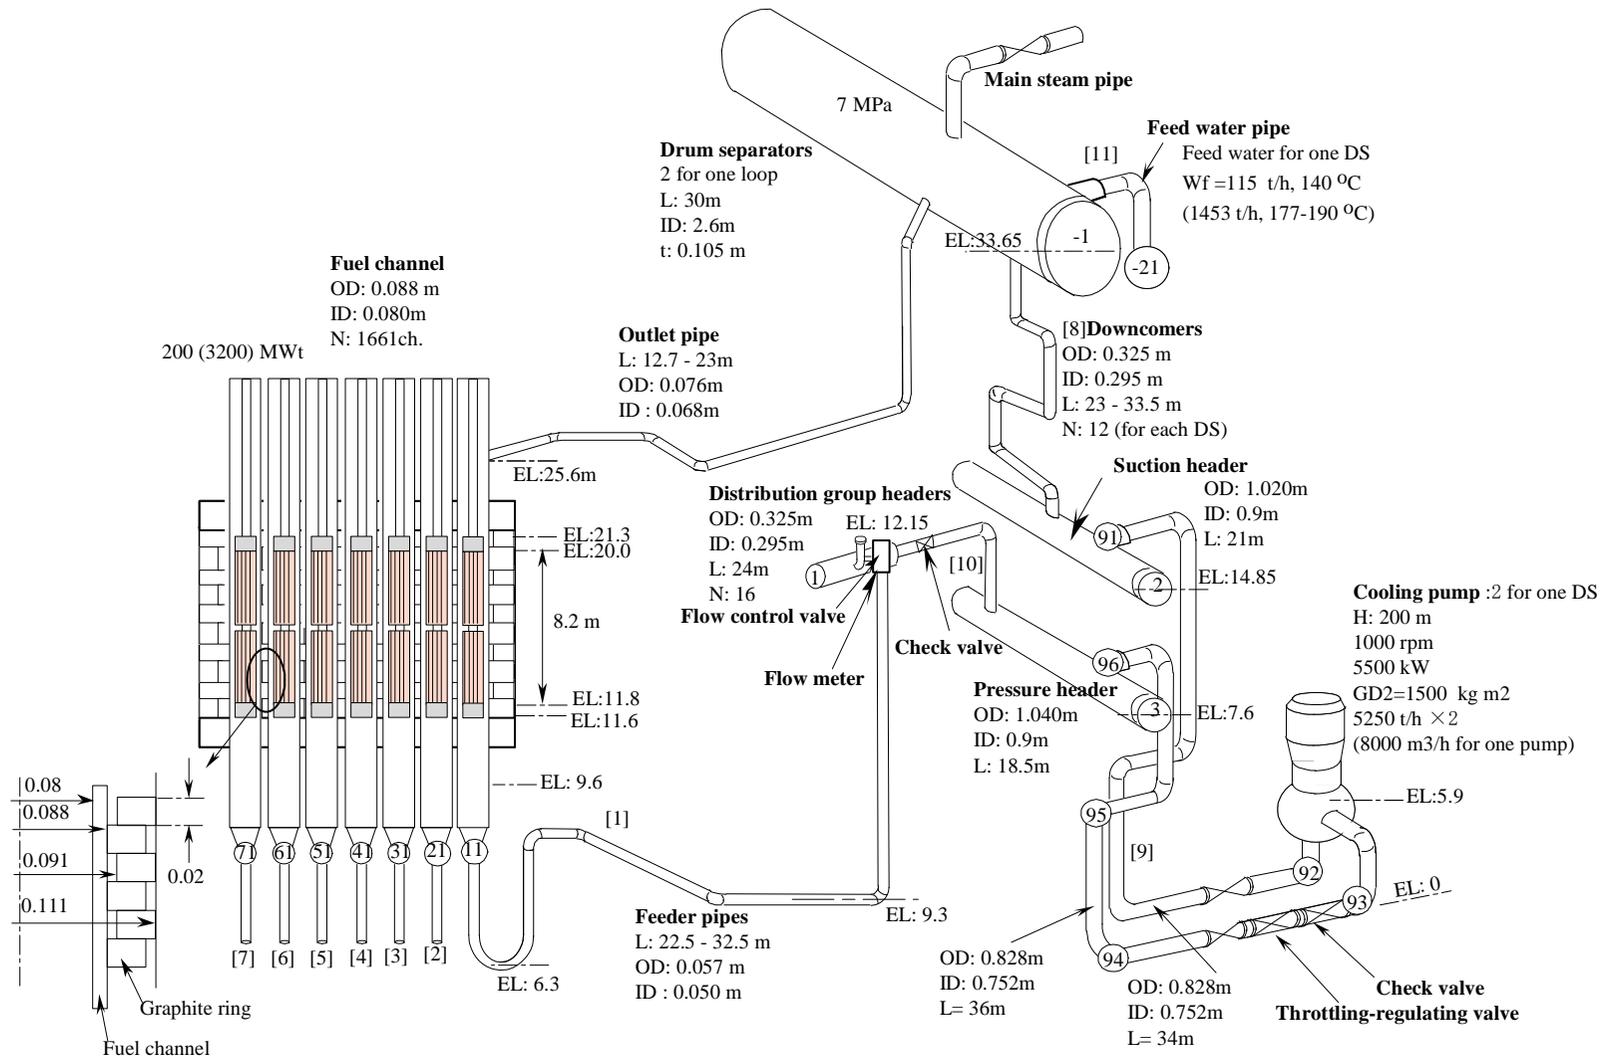
Calculation Model by NETFLOW++ Code

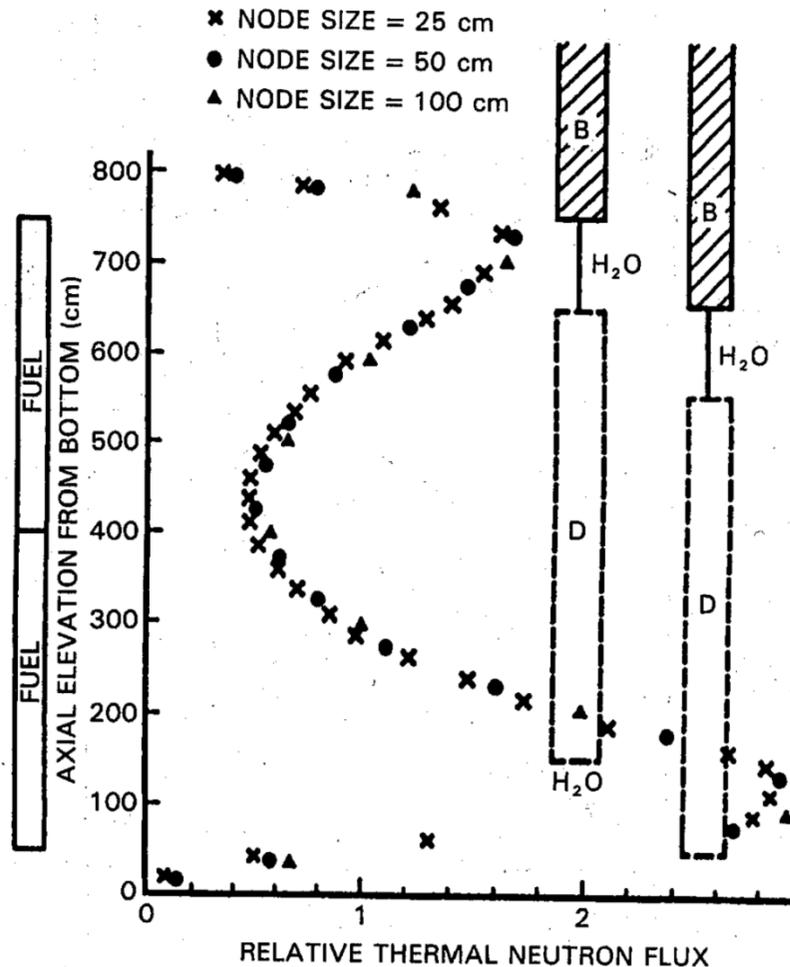
Fig. 1. Effect of node size on axial flux distribution. In this figure, B = B₄C absorber and D = graphite displacer.

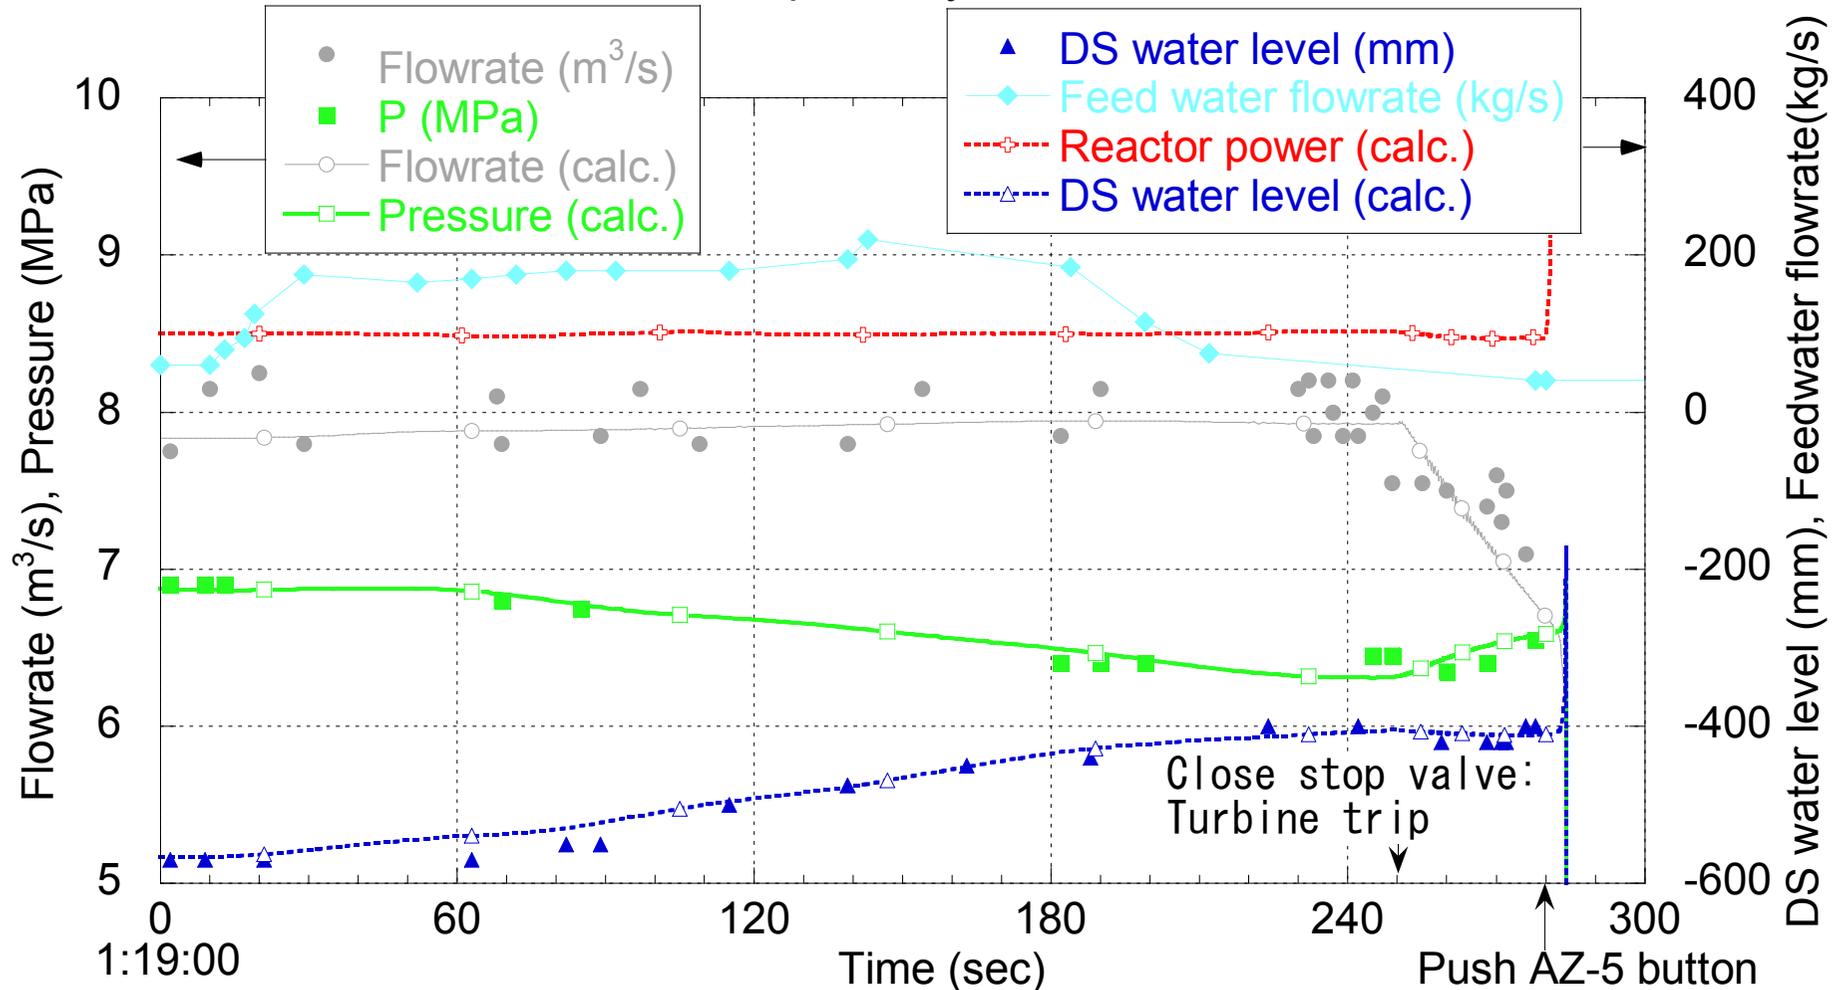
Data acquired by SKALA

Trend of parameters for one loop from 1:19:00 on 26 April 1986

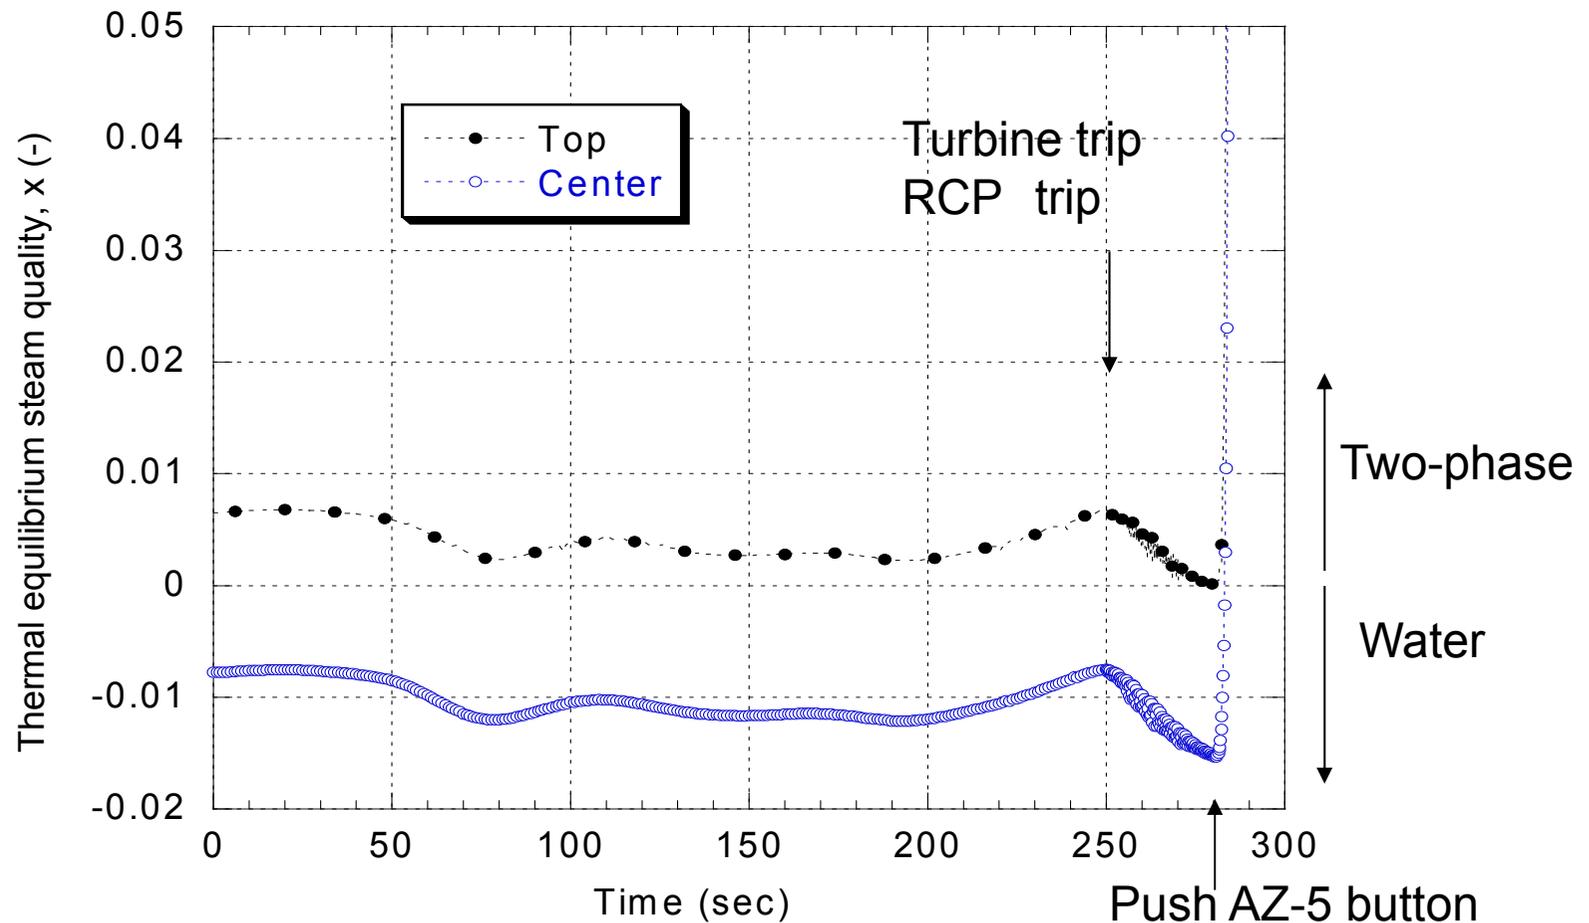
Behavior of Steam Quality

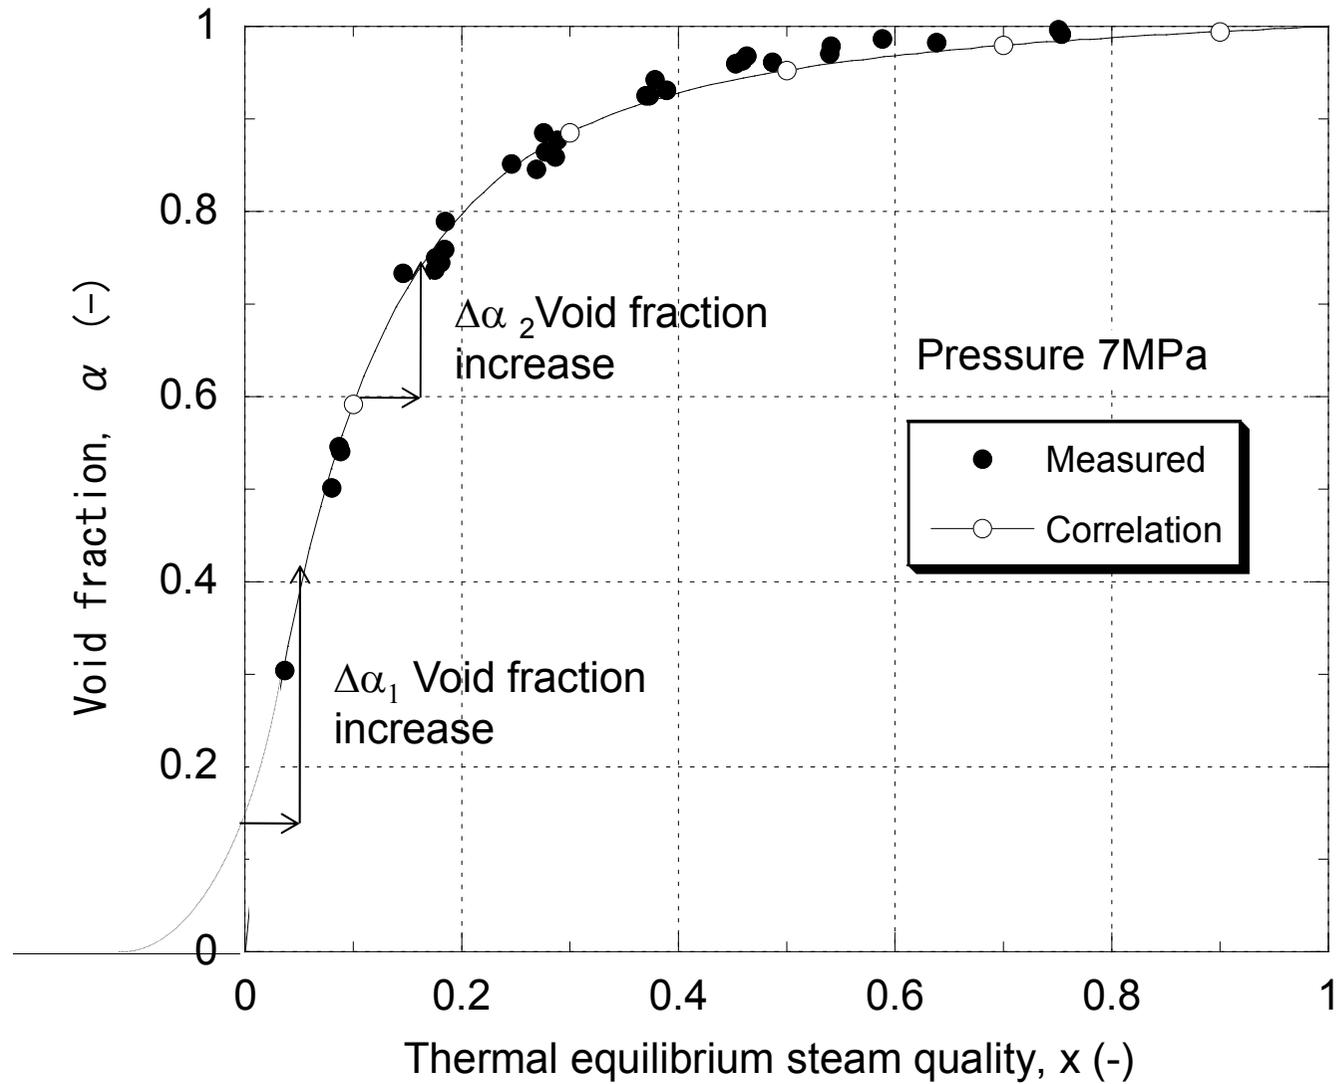
Void Characteristic

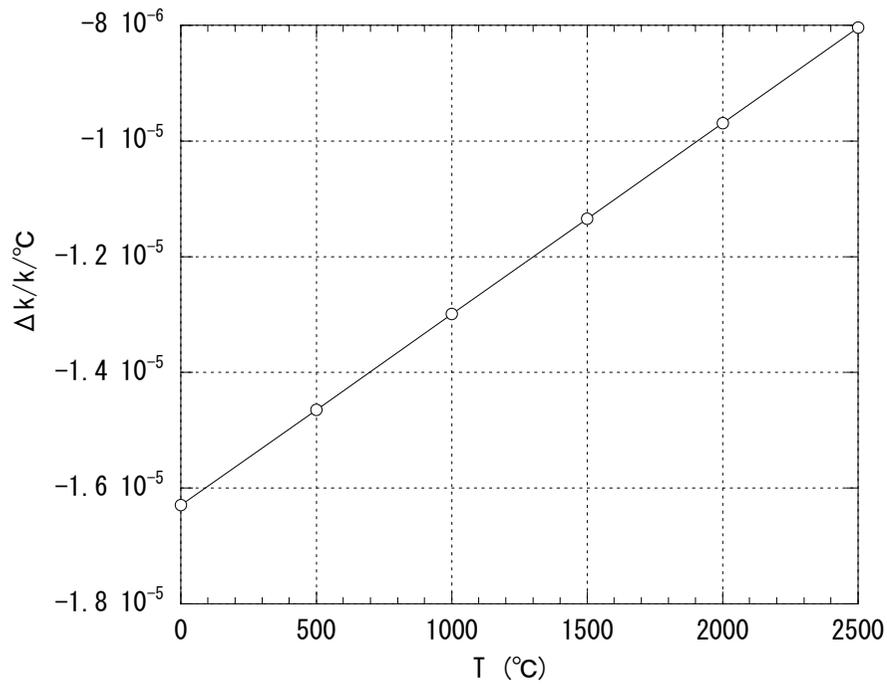
Doppler

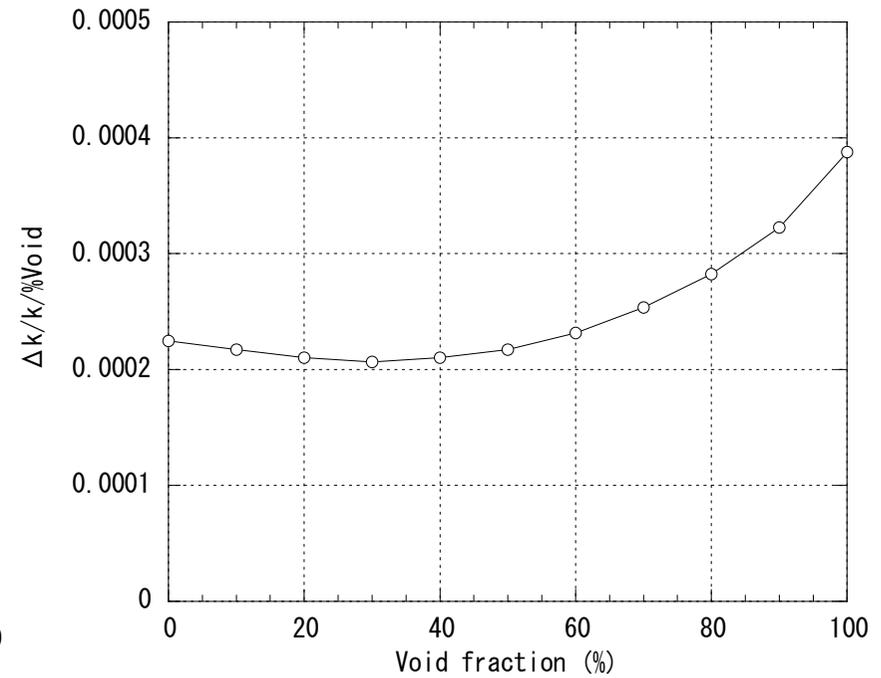
Void

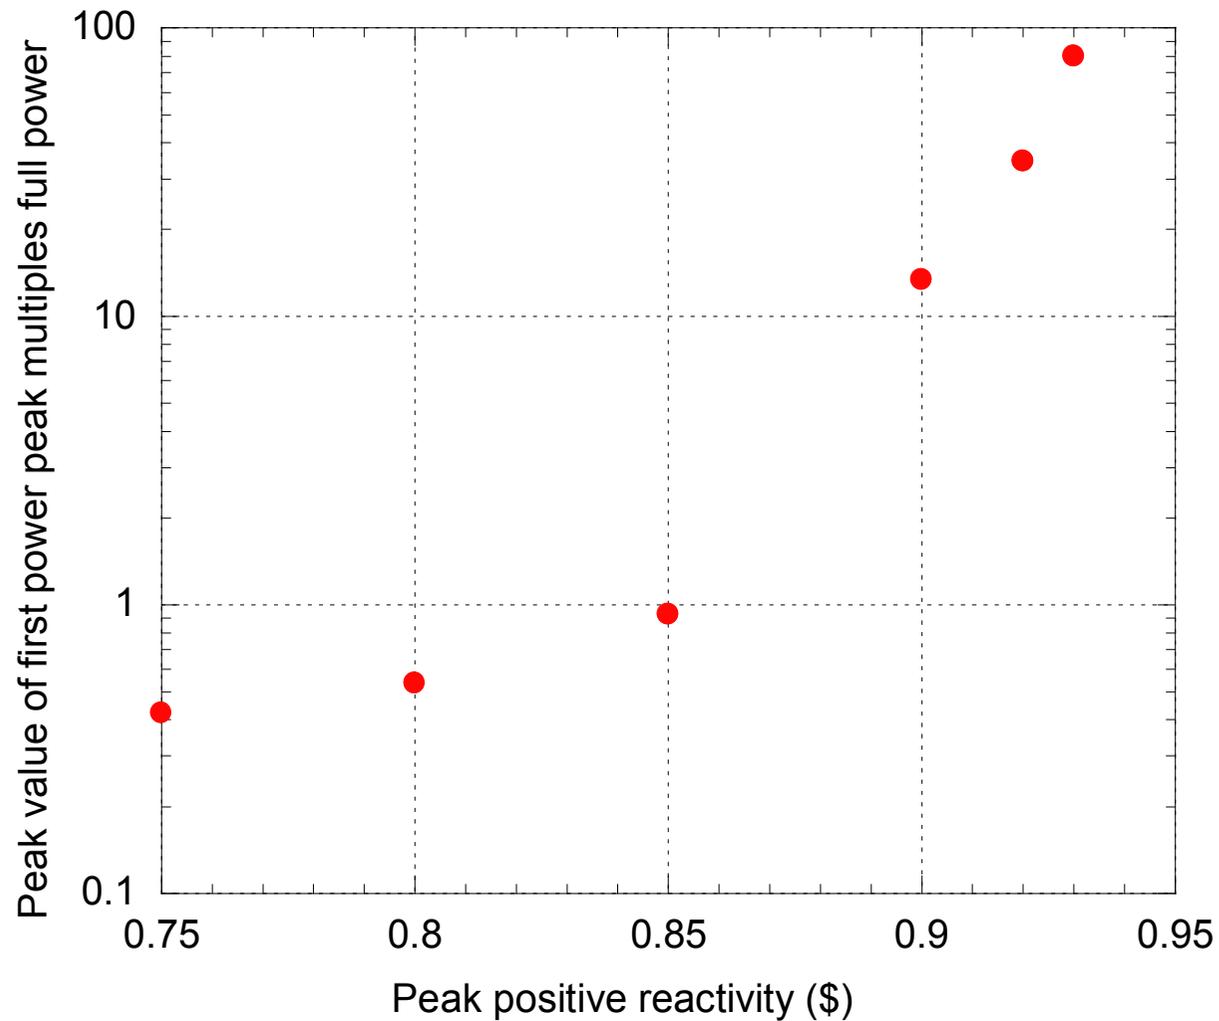
Relationship between Peak Power and Peak Positive Reactivity

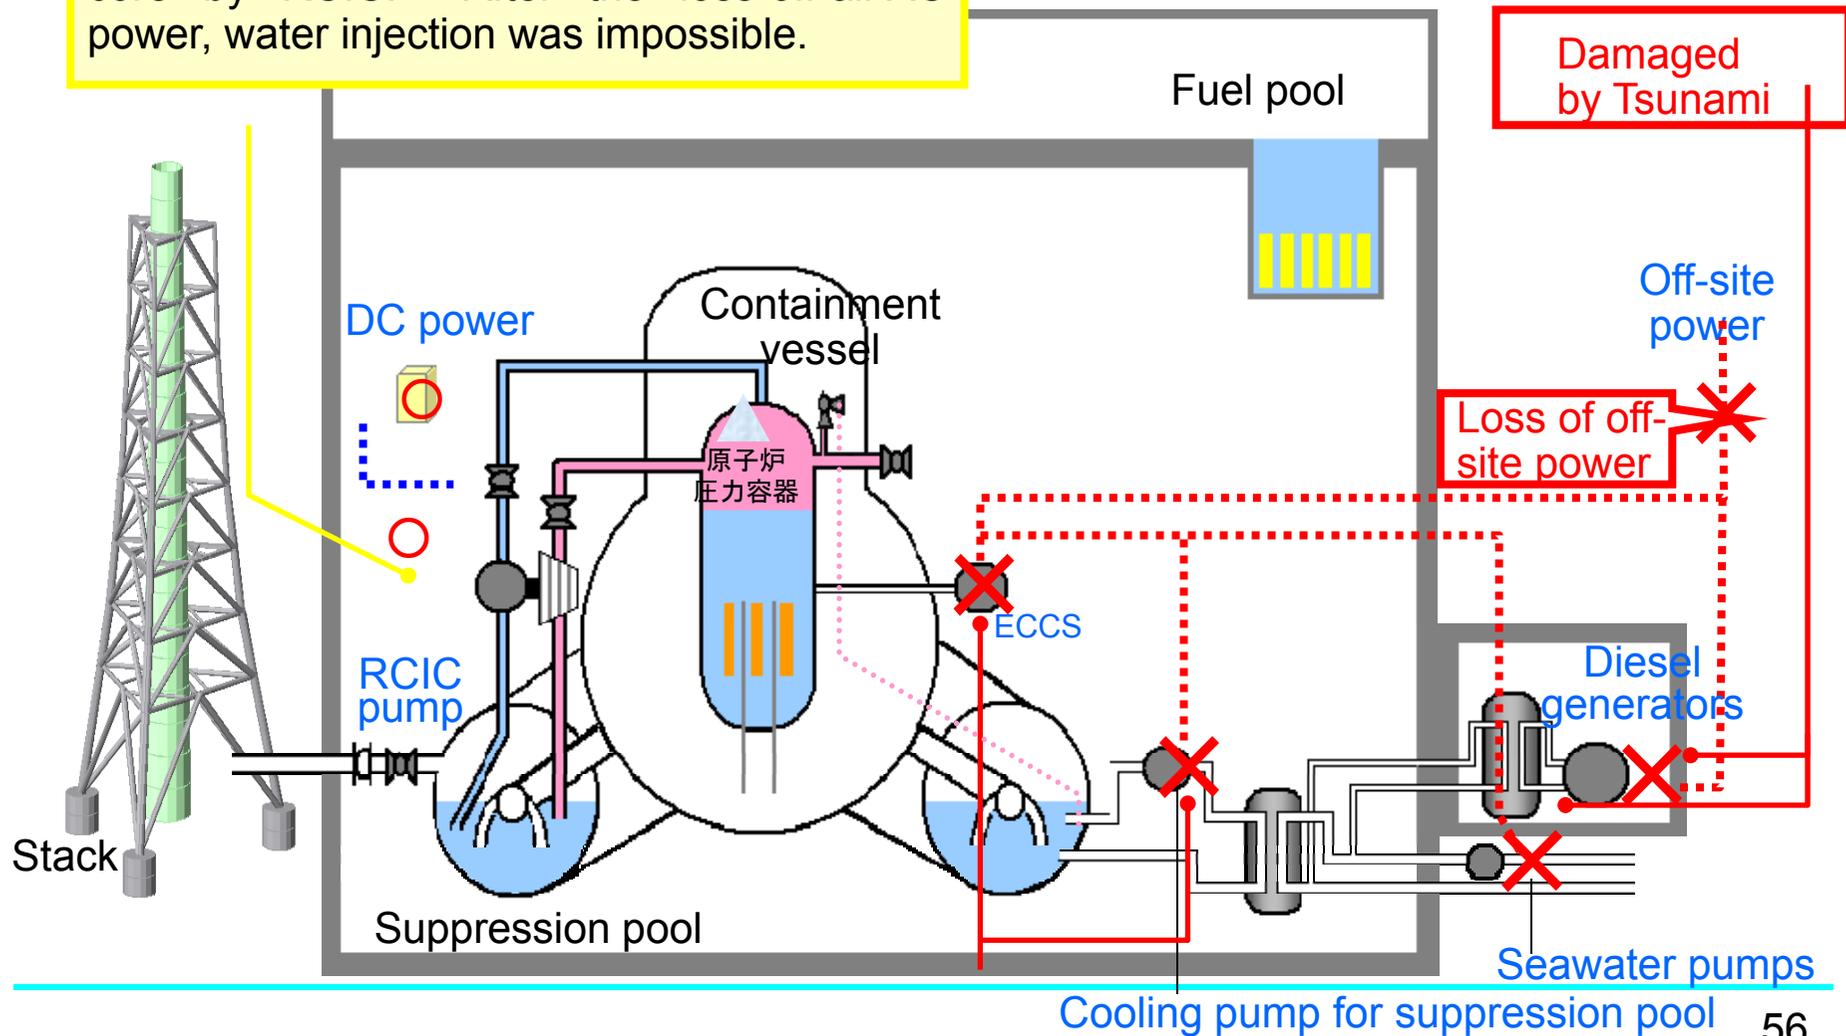
Operators injected water into the reactor core by RCIC. After the loss-of-all-AC-power, water injection was impossible.

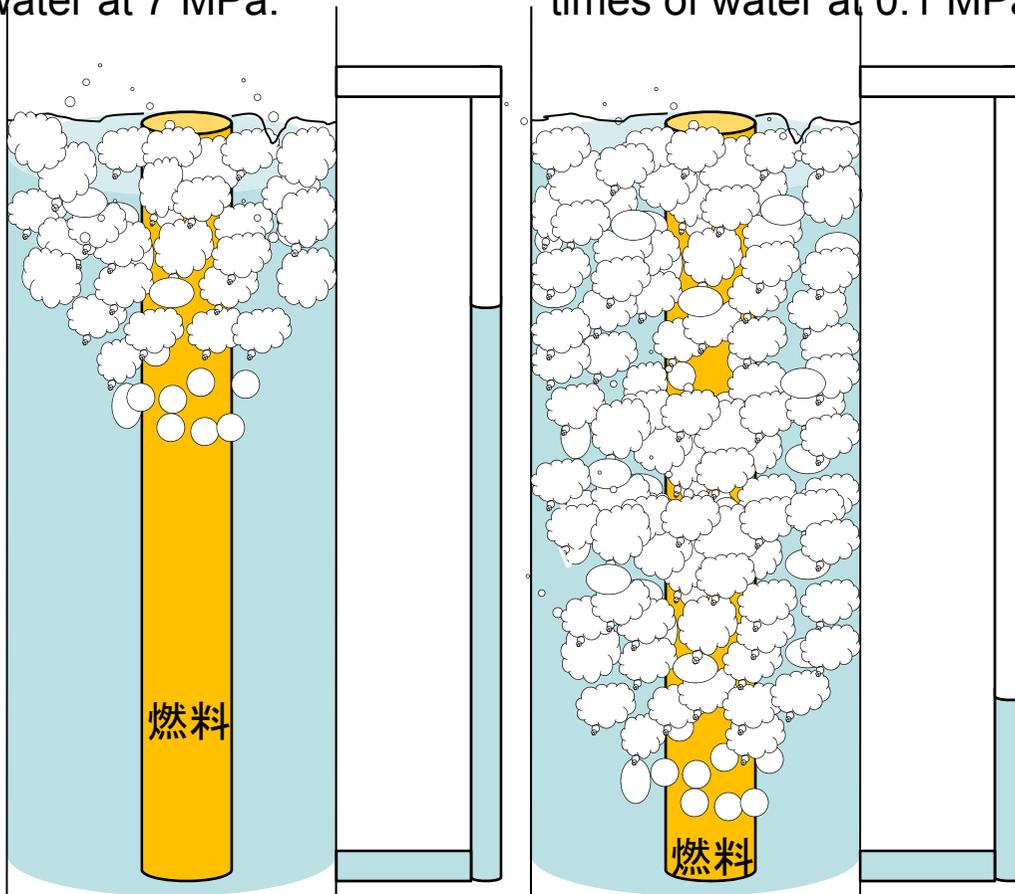
High pressure (Core)
Volume of steam expands 21 times of water at 7 MPa.

Low pressure (Spent fuel pool)
Volume of steam expands 1600 times of water at 0.1 MPa.

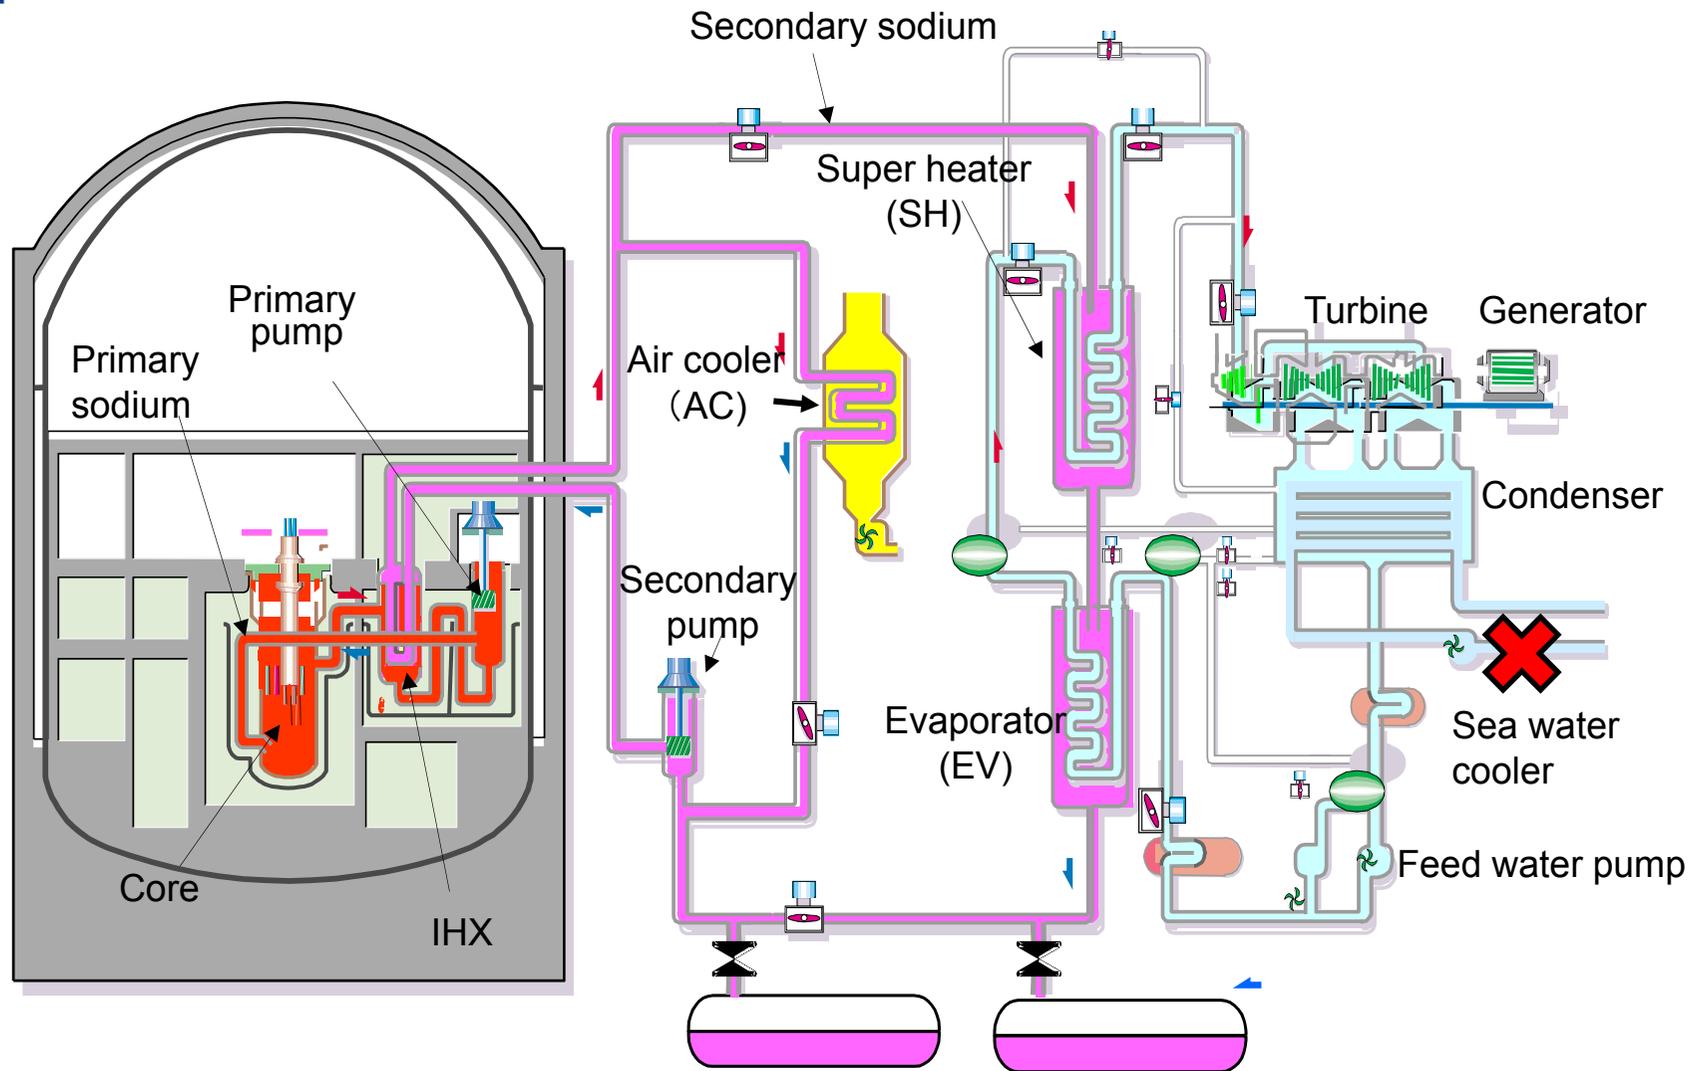
Natural circulation after the loss of AC power and sea water pump

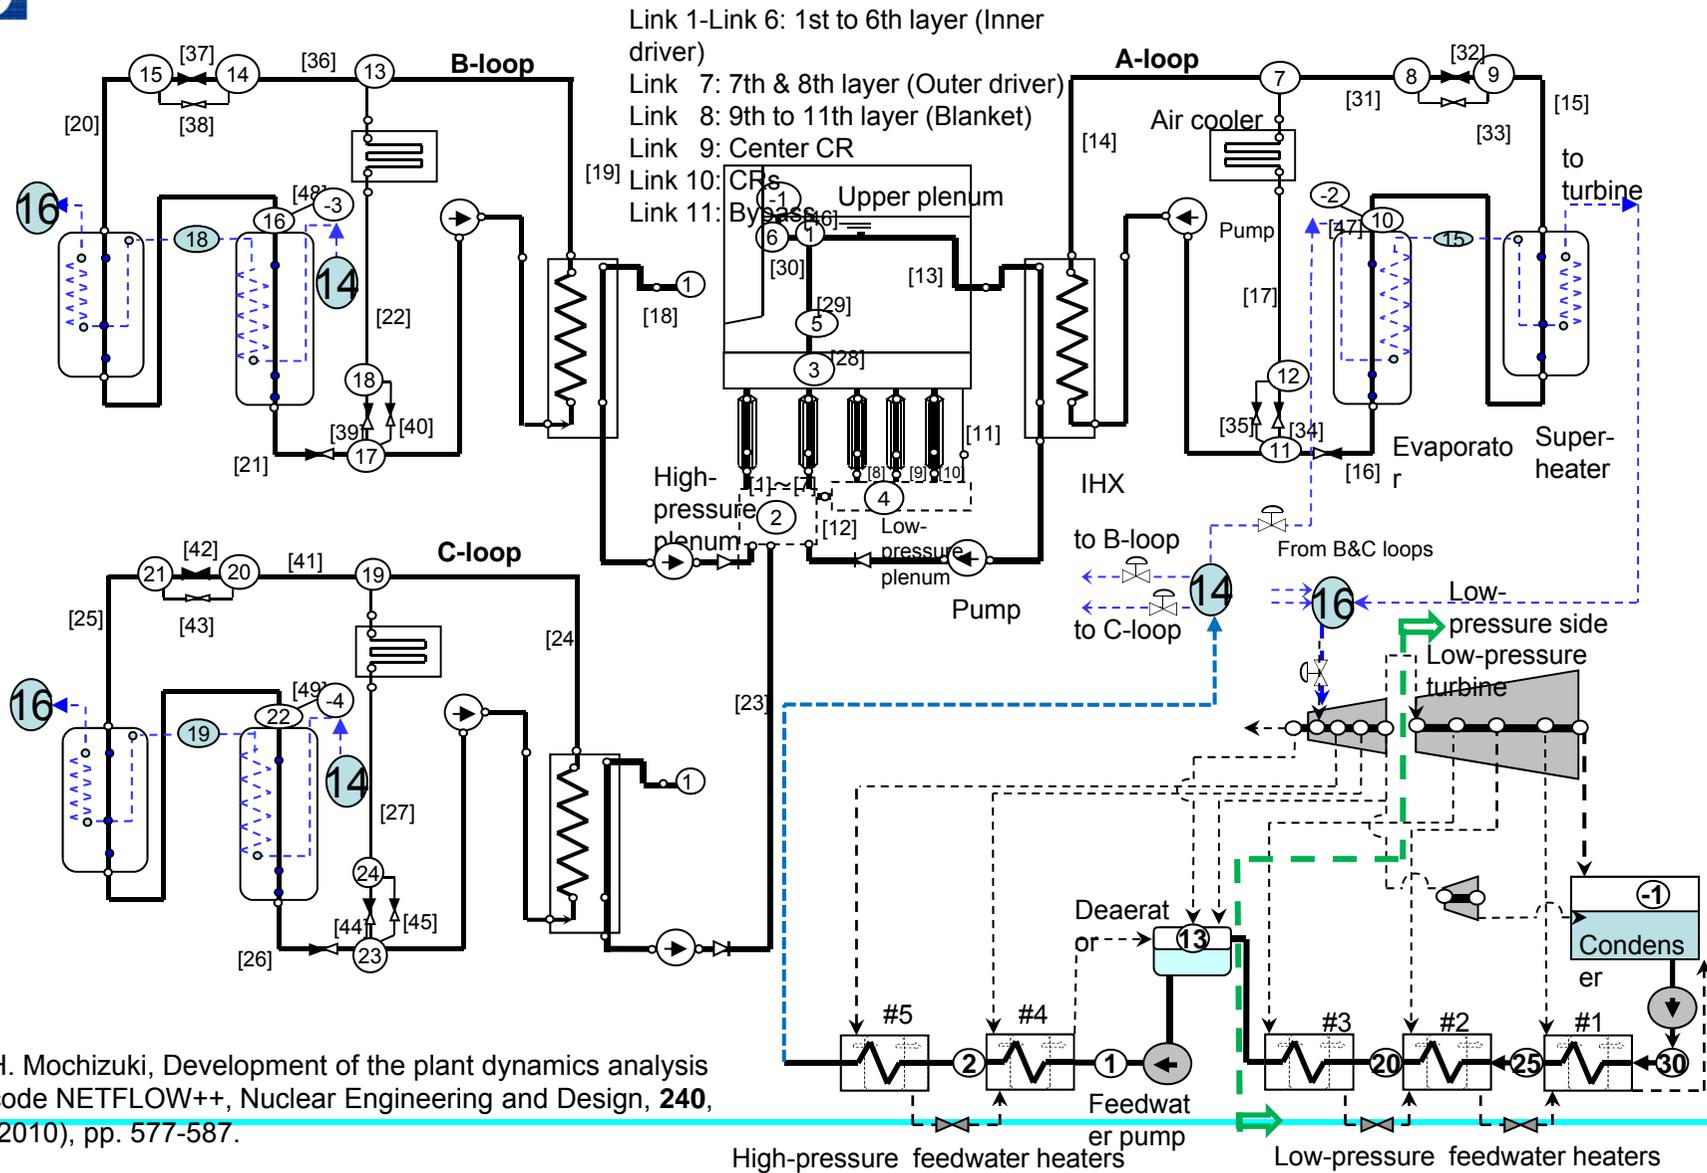
Analytical Model of Whole Heat Transport Systems

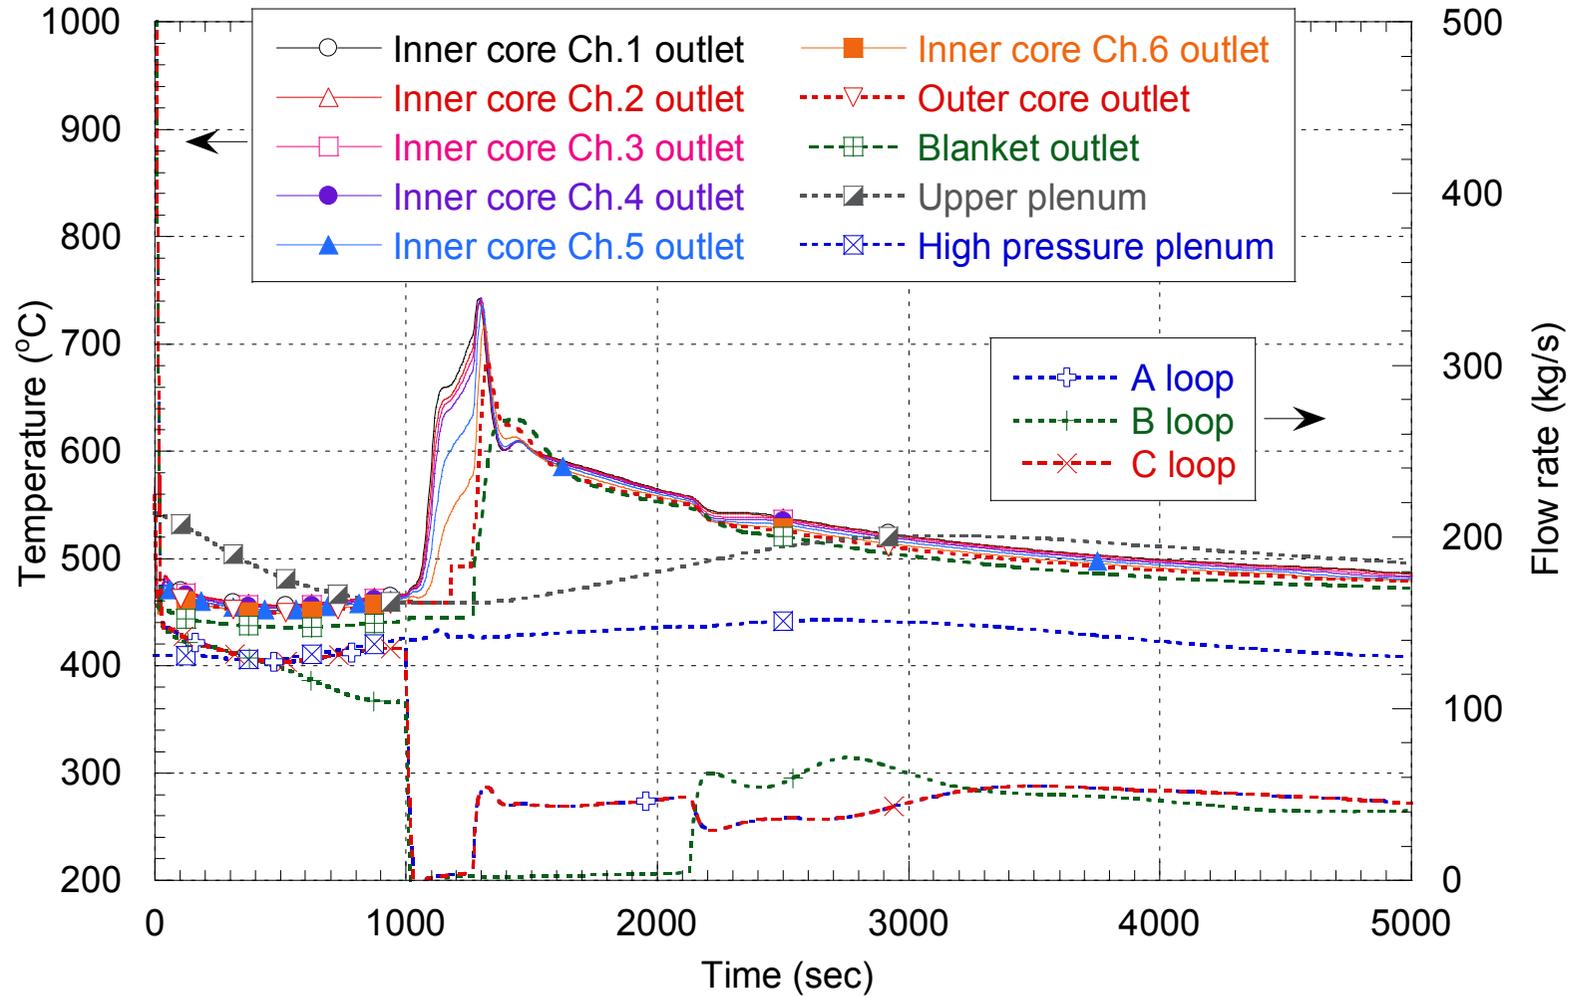
Station Blackout at 10000 sec.
